CONCESSION OF 33 SILO COMPLEXES IN NIGERIA

DUE DILIGENCE REPORT- VOLUME B

TECHNICAL DUE DILIGENCE

March 2015

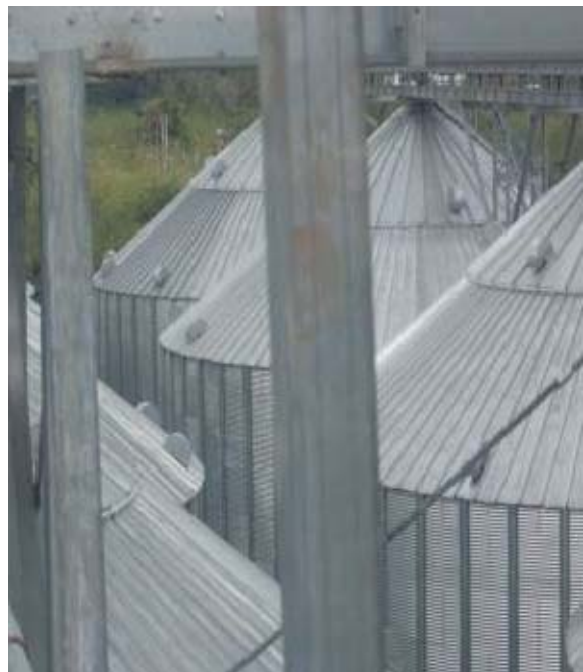
Photo 11: Rust On Section Of Bin Roof Cover

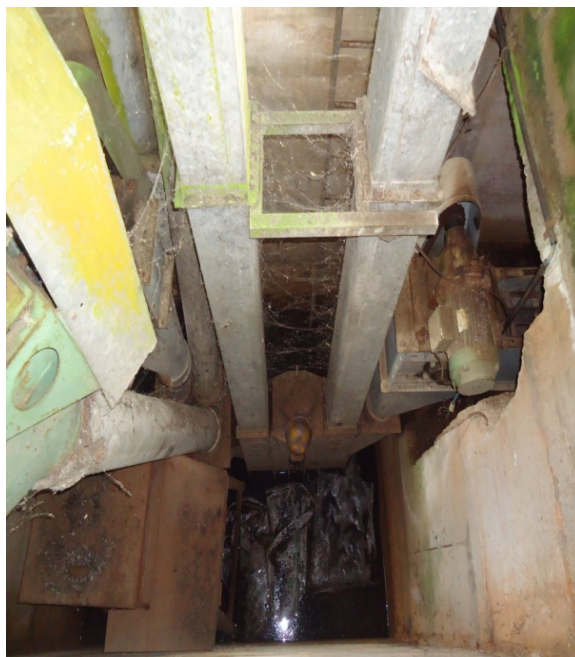
The assessment of the condition of the equipment and infrastructure is presented in Annex C. All silo bins are suffering from roof leakage and seepage at the base. They're also lacking sweep & discharge augers. Hospital bins are also showing seepage at the base. The bagging plant needs to be replaced and the bulk loader upgraded. Workshop tools and laboratory equipment should be provided. The grain cleaner requires in also in need of repair. Water supply is lacking and a borehole needs to be drilled. In terms of civil structures, the administrative and workshop block require some minor repairs. The utilization potential of this Complex is 74.5%.

Photo 211: Rust Silo Bin Base

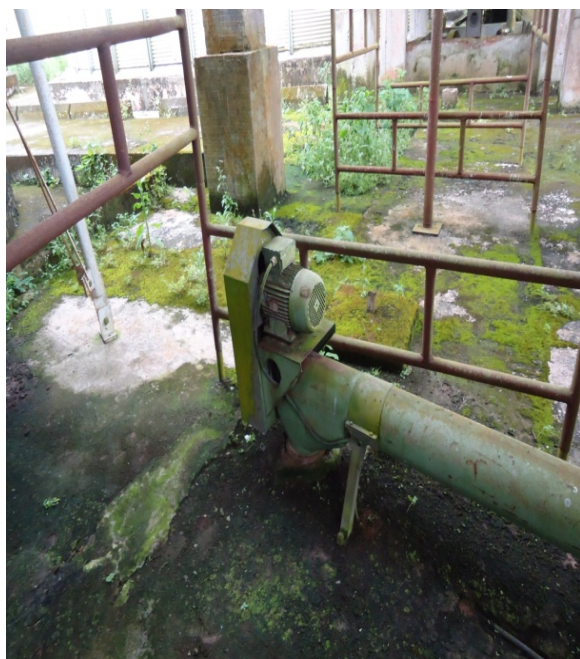
Photo 214: Elevator's Pit Electric Motor Showing Sign Of Rust

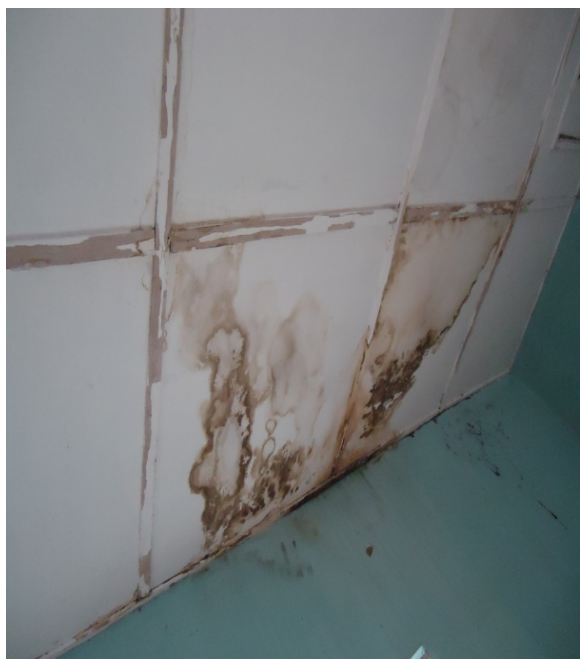
Photo 216: Building Wall Affected By Dampness

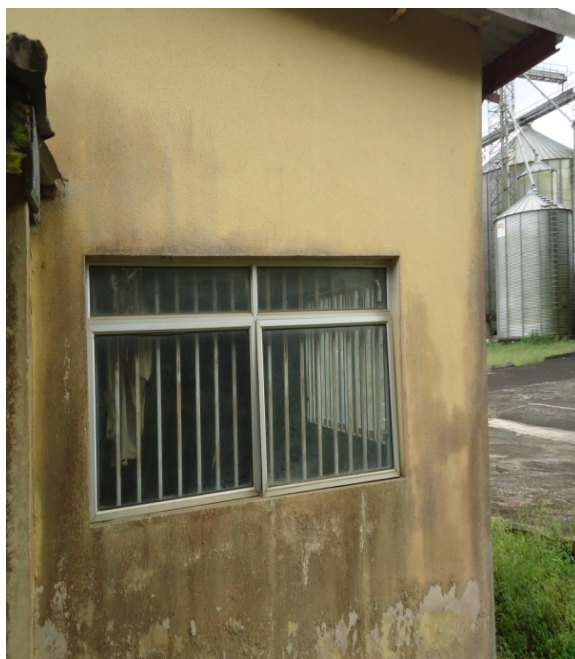
Photo 217: Roof Leakage

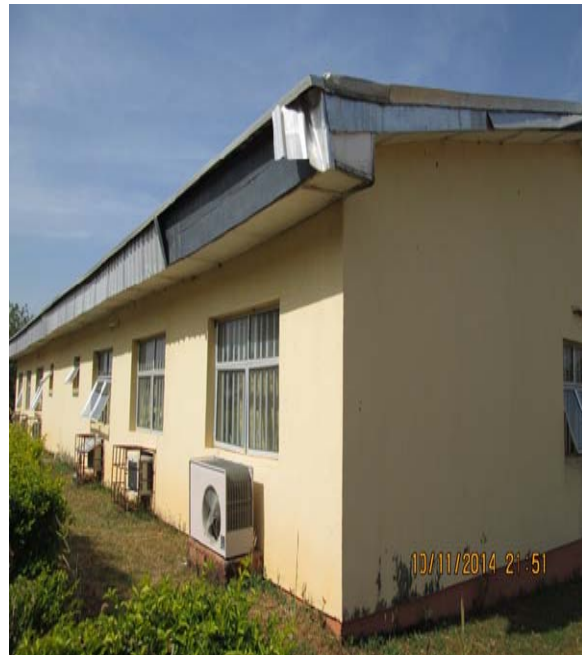
Photo 263: Warehouse Blown-Out Roof Covers
