CONCESSION OF 33 SILO COMPLEXES IN NIGERIA

DUE DILIGENCE REPORT – VOLUME C

ENVIRONMENTAL & SOCIAL DUE DILIGENCE

March 2015

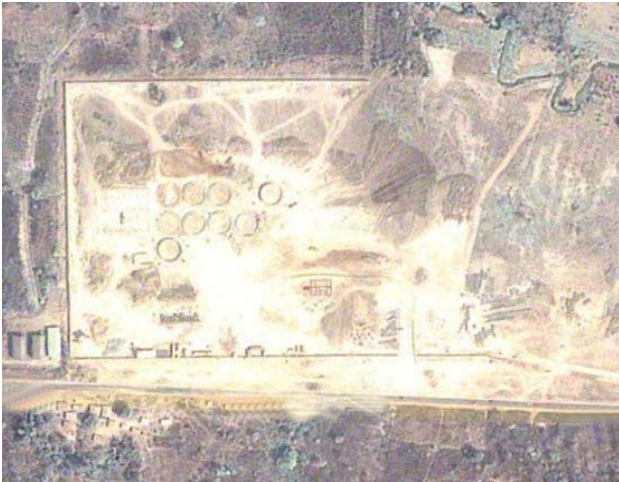
Figure 1: Aerial view of Ado-Ekiti Silo Complex during construction

The Silo Complex is located along Polytechnic Road in Ado-Ekiti, Ekiti State. The Complex has a storage capacity of 100,000 metric tons. Construction is still on-going at the Silo Complex. The completed sections of the Complex are well maintained and kept clean (Figure 1, Figure 2).

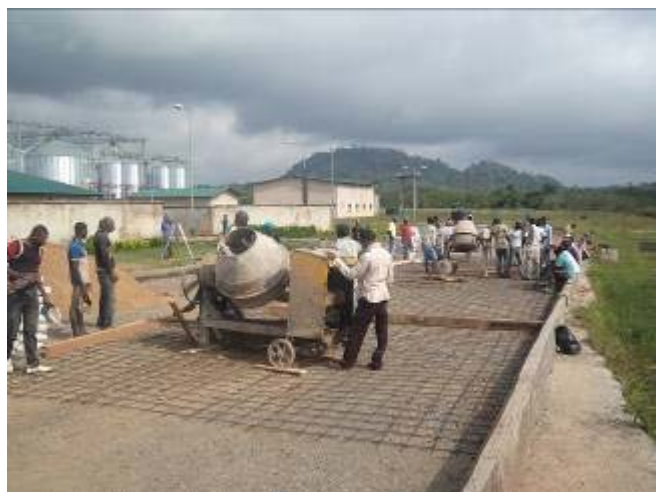
The construction workers do not comply with HSE standards (Figure 3) but no accidents have been recorded so far. Since the Silo Complex is not yet operational, there are no complaints or observed threats to the environment and personnel health resulting from the Complex operations.

Figure 3: Construction work without appropriate PPE

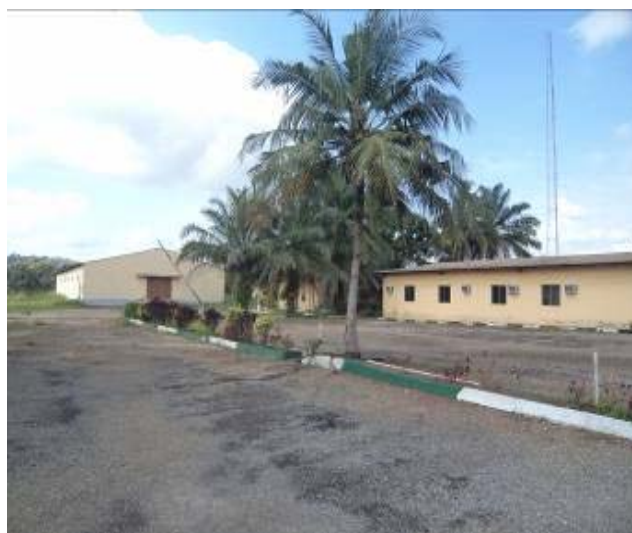
Figure 6: Administrative Buildings in Akure Complex

The Silo Complex is relatively well kept (Figure 6). However, disposal of waste/spoilt grains are a problem at this site. Waste generated in this Silo Complex is mainly from caked grain, moulded grain and spill-over wastes. Collected wastes are openly burnt. Waste oil and service parts (oil filters) are either indiscriminately poured away or disposed. Chemicals (such as Coopex Grain Dust and Phosphine) are stored in pallets at the nearest Administrative block to the silos.

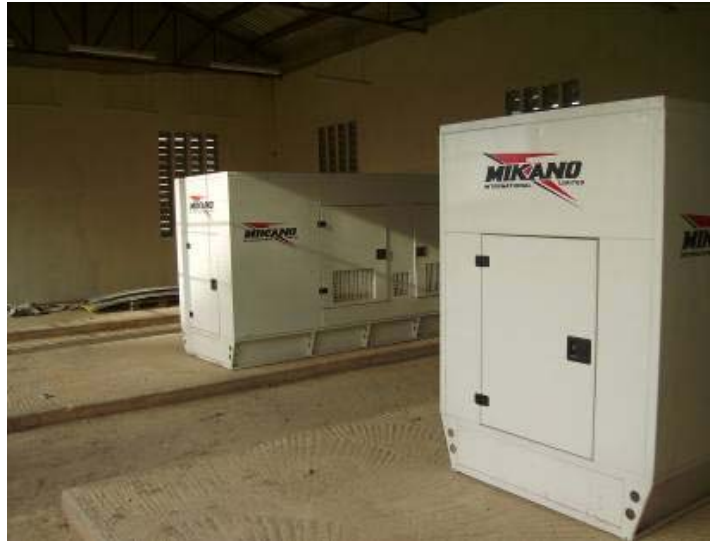
Figure 8: Bauchi Silo Complex Relatively Well Maintained Generator House

The Silo Complex has been well maintained and the generator house is good condition (Figure 8).

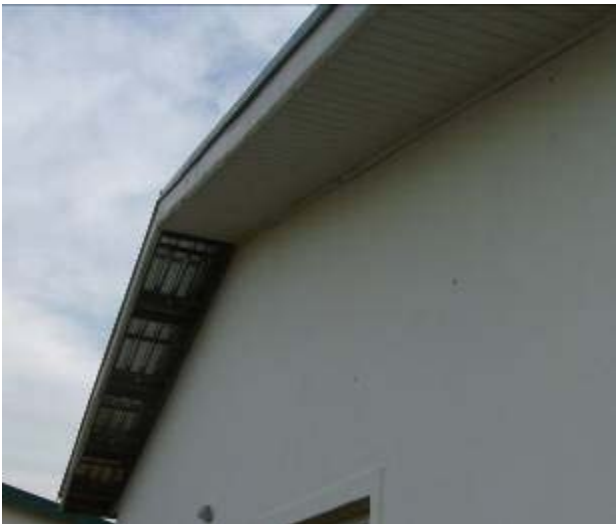
Wind gusts have been reported to have had some effect on ceiling soffits on the administrative block (Figure 9, Figure 10).

Figure 9: Wind damaged roof

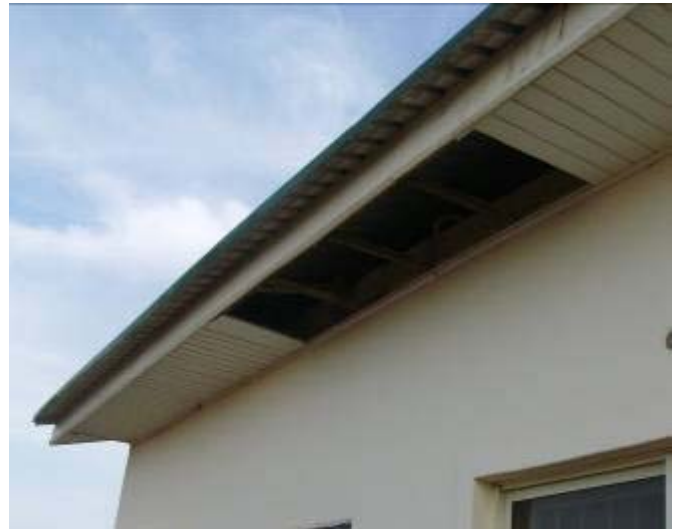
Figure 10: Wind damaged roof (2)

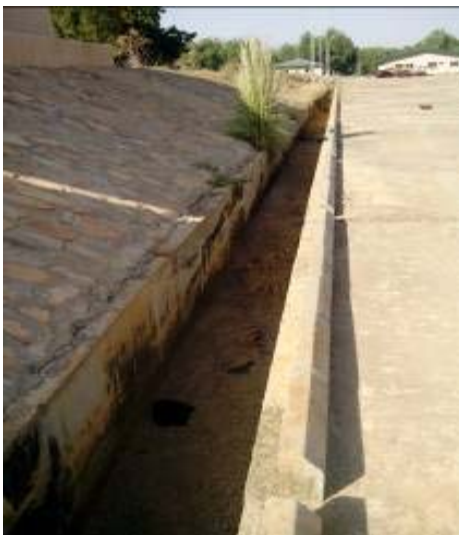
Figure 13: Drainage with the Complex

The Complex is well drained and there are no problems of soil erosion or wind gusts. This may be attributed to the presence of drainage and trees around the Complex (Figure 13, Figure 14).

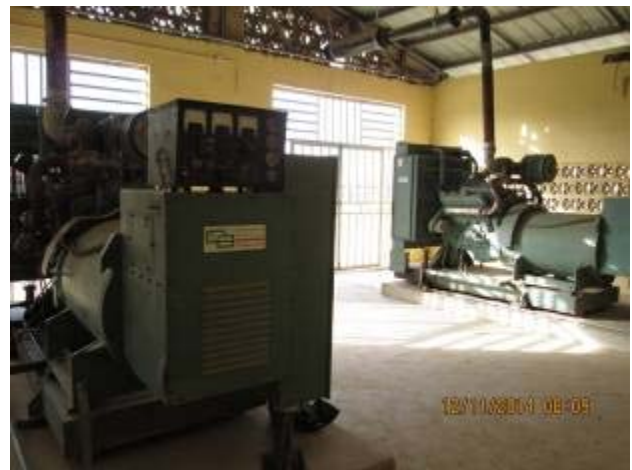
Figure 17: Generator House

There is no surface water body in close proximity to the Complex. Therefore, there is no threat of possible pollution of surface water body by future operation of the Silo Complex. There were no observable bushes within the Complex. The generator and maintenance buildings are still very clean as operational activities are yet to commence (Figure 17). Overall, the Complex is well maintained.

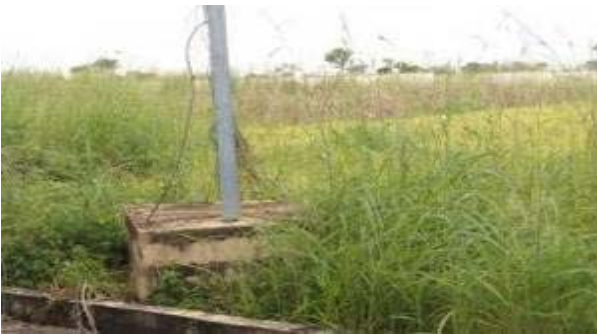
Figure 19: Fencing overgrown with weeds

Although portions of the Complex premises are overgrown with weeds (see Figure 19 and Figure 20), the Complex is generally well maintained. The generator house is clean and free from any oil or diesel spill. This may also simply be as a result of the non-operational status of the Complex (Figure 21).

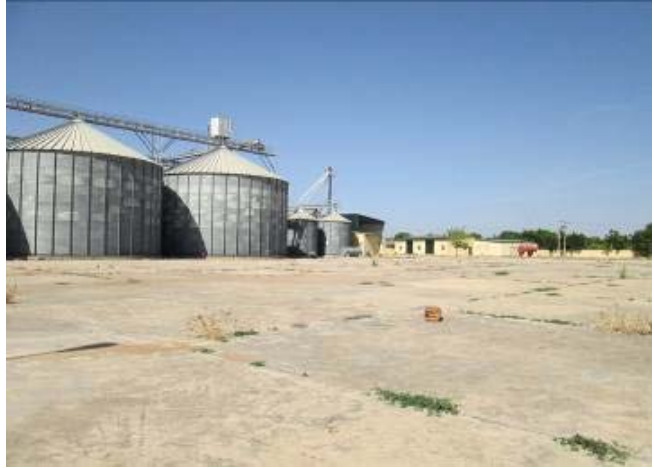
Figure 22: Patches of Grass Growing on Pavement

Though the Complex is still under construction, the premises is well drained and relatively clean, though patches of grasses were observed growing on the concrete pavement (Figure 23).

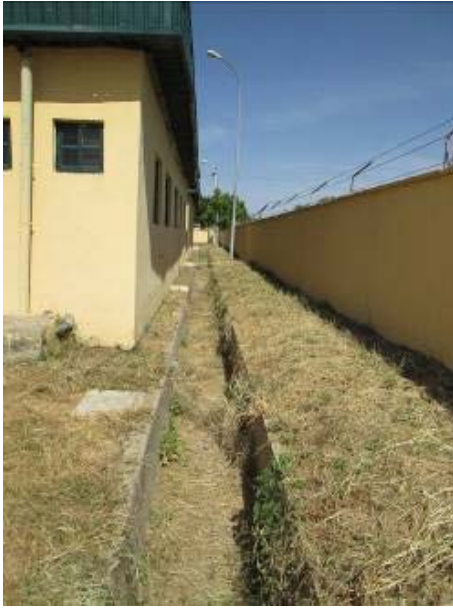
Figure 25: Drainage at Perimeter

There are no surface water bodies nearby the Gaya Silo Complex. In addition, some of the drainages were observed to be blocked with cleared grasses (Figure 24) and would require to be cleared to allow free flow of storm water.

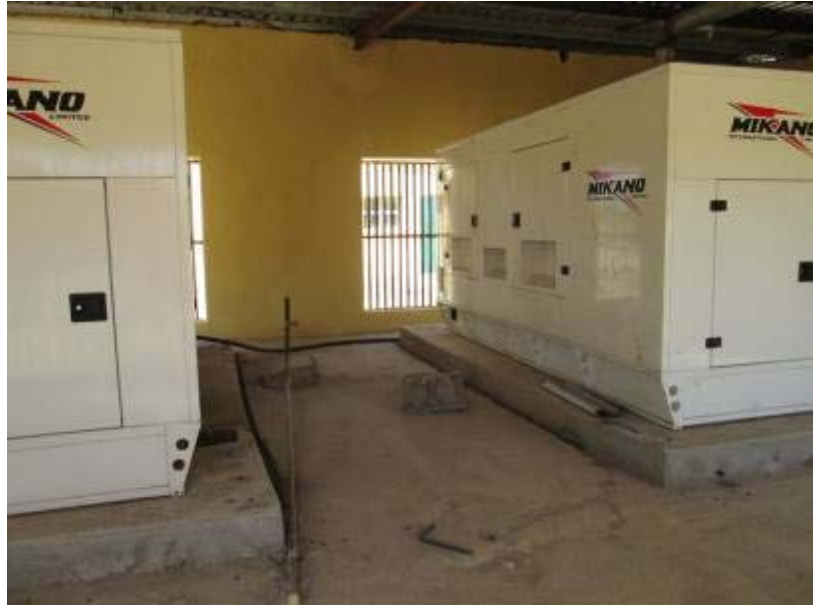
Figure 24: Generator House

The generator house is still clean with no trace of oil or diesel spill (Figure 25).

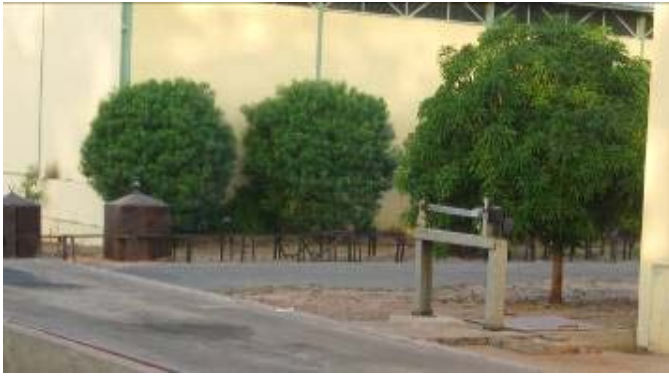
Figure 29: Roadways and Trees

In spite of the existence of trees planted around the Complex, parts of structures within the Complex were observed to be affected by possible wind gust (Figure 28, Figure 29).

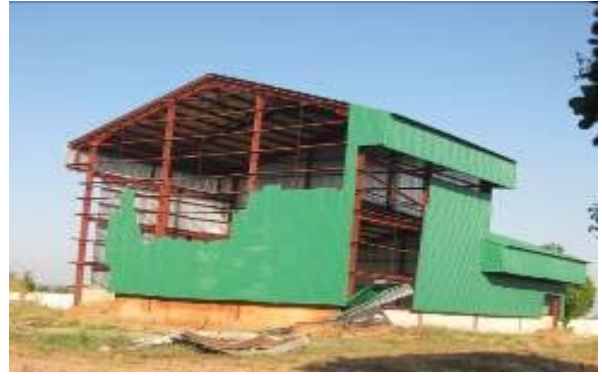
Figure 28: Damaged building, possibly by wind

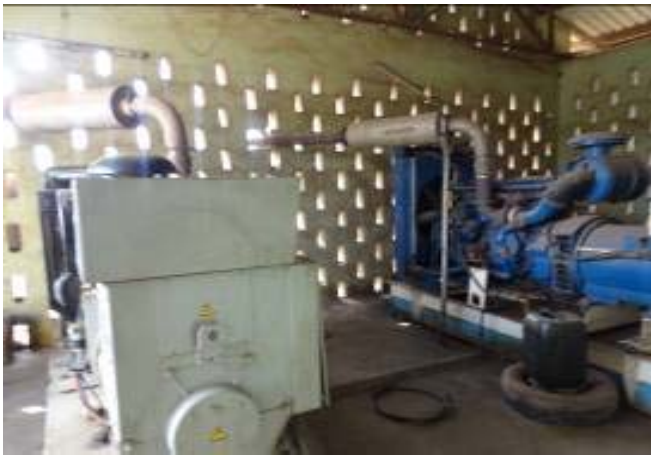
Figure 37: Generator House

The generator house is clean and there have not been any complaints of noise pollution emanating from the three available generators (Figure 36).

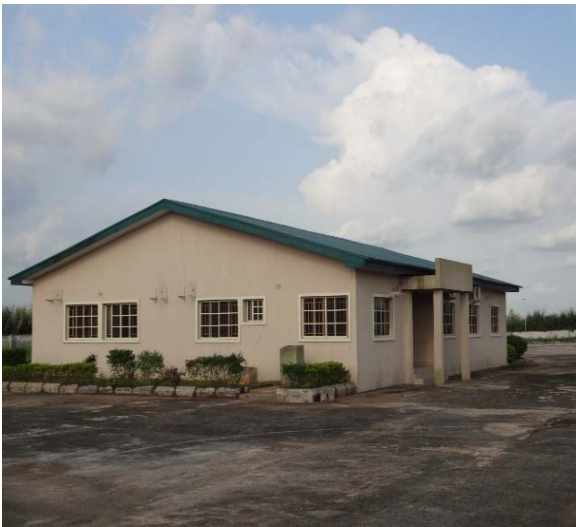
Figure 44: Administrative Building

The Complex is well maintained (Figure 44, Figure 45) and there are no environmental concerns which could be attributed to operational activities as the Silo Complex is yet to be put to use.

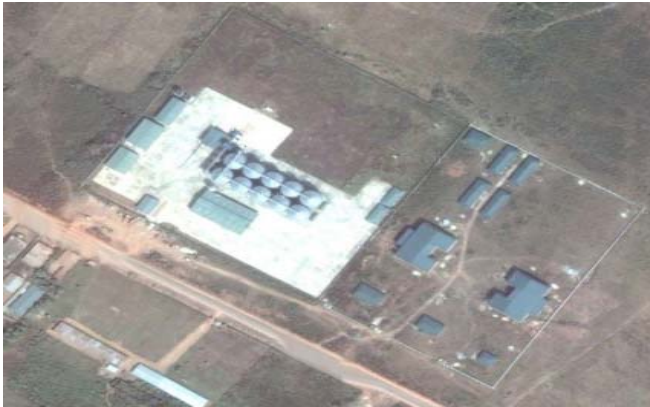
Figure 47: Aerial View of the Ilesha Silo Complex

The Silo Complex looked clean with relatively little or no environmental management concerns as the facility is not in operation (Figure 47).

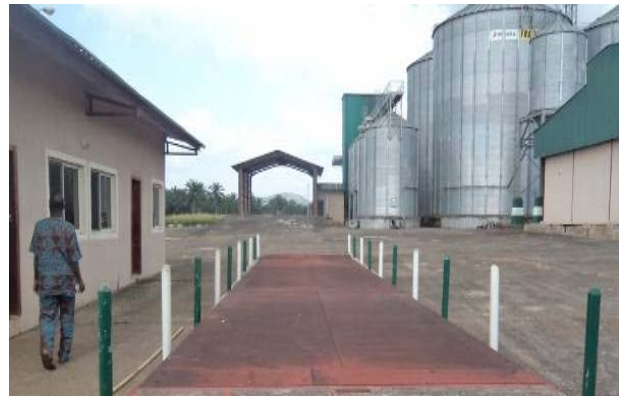
Figure 46: Weigh Bridge at Ilesha Silo Complex

The Ilesha Silo Complex, which is due for commissioning and has a capacity of 25,000 metric tons, is located along Irojo Road in Ilesha East Local Government Area of Osun State (Figure 46). Construction is completed but the Complex is not yet handling grains.

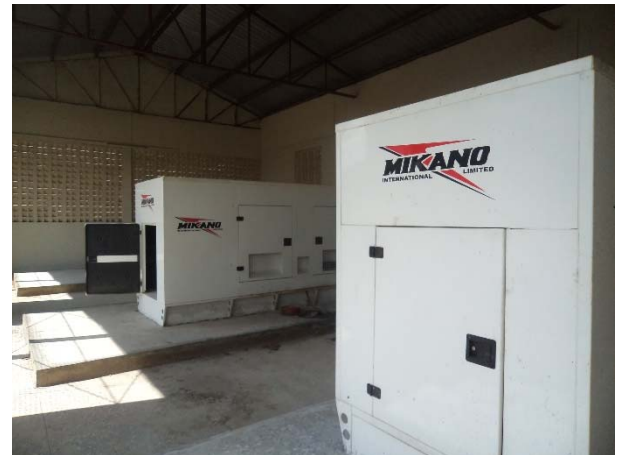
Figure 48: Well-Maintained Generator House

The generator house is clean and there has not been any complaints of noise pollution emanating from the two available generators. The waste oils from the generator are used to lubricate chains (Figure 48).

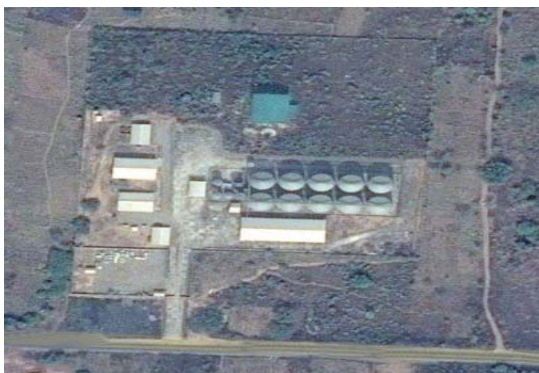
Figure 49: Aerial view of Ilorin Silo Complex

Ilorin Silo Complex is operational and is located at Km 14, old Jebba Road, Oke-Ose in Ilorin, East Local Government Area of Kwara State (Figure 49). The facility, has an installed capacity of 25,000MT was and commissioned in 2006. The Complex is currently operational.

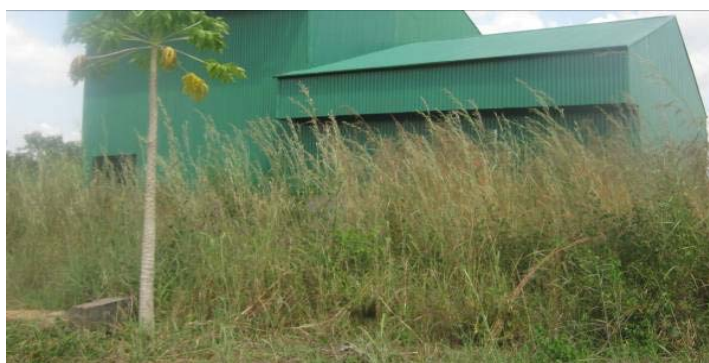
Figure 50: Overgrown bushes within the Complex

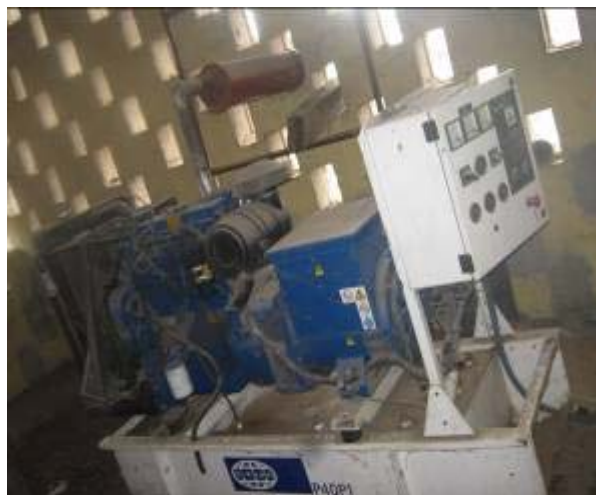
Figure 51: Generator House

The generator houses are clean and well kept (Figure 51). Used service parts are usually kept in the store. According to the information gathered at the Complex, the generators are serviced twice a year when receiving and releasing grain. There is no significant noise impact from the generators during operation.

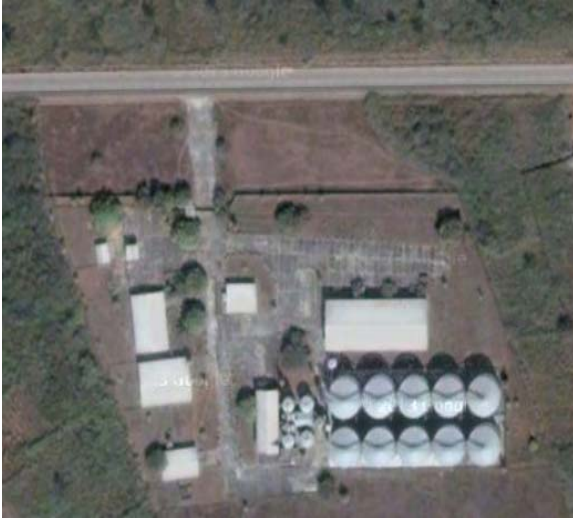
Figure 52: Aerial View of Irrua Silo Complex

The Complex which has an installed storage capacity of 25,000 metric tons is located along old Irrua Road, Irrua in Esan Central Local Government Area of Edo State (Figure 52). It was commissioned in 1994. The Complex is currently operational.

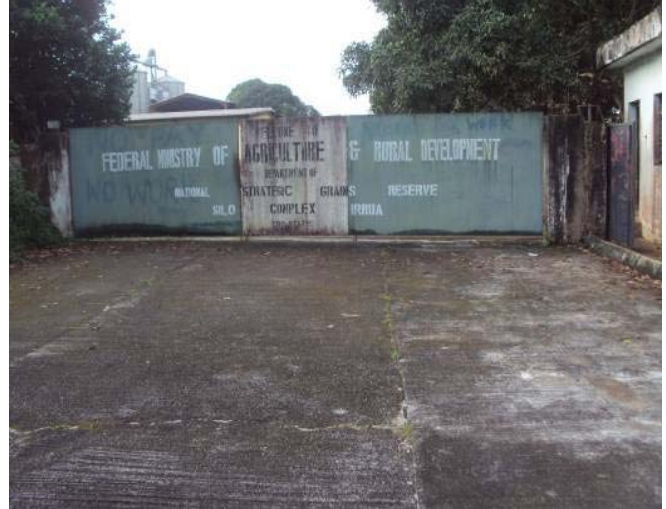
Figure 53: Gate view of Irrua Silo Complex

The Irrua Silo Complex (Figure 53) as observed during the inspection mission, faces some environmental and social challenges and would therefore require some environmental and social improvements. Though the Complex is located on a well-drained terrain, certain portions of the compound are overgrown with weeds and bushes as shown in (Figure 54). This has also contributed to the presence of rodents, insects and reptiles within the Complex.

Location	Identified Issue/Impact	Mitigation Measure	Estimated Mitigation Cost
Portions within the Complex	Overgrown bushes	Ensure regular clearing of the Complex by engaging local labour.	N100,000 per/year
Parts of the Complex	Algae growth on certain parts of the Complex	Outsource the regular sweeping of the Complex to women association from the host community.	N50,000/month
Silo Complex	Risk of injuries and accidents	Provide appropriate PPEs and strictly enforce use by all staff.	N20,000/staff
Silo Complex	Indiscriminate disposal of solid waste (decayed grains), used oil and service parts.	Provide appropriate dump site that is well contained and enforce strict use of the dumpsite. Develop and enforce relevant policies within the Complex. Educate workers against indiscriminate waste burning.	N150,000 per dumpsite construction

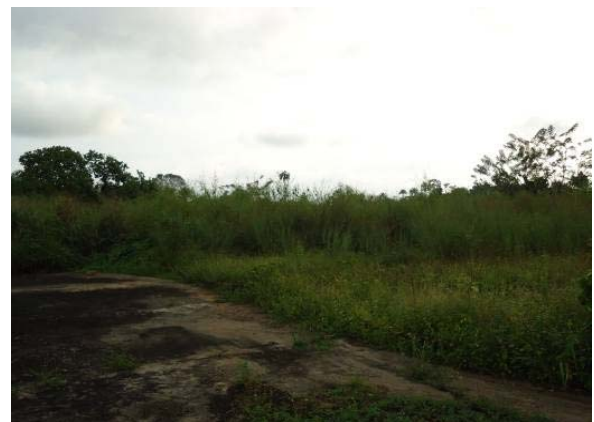
Figure 54: Area of Silo Complex Overgrown with Bushes

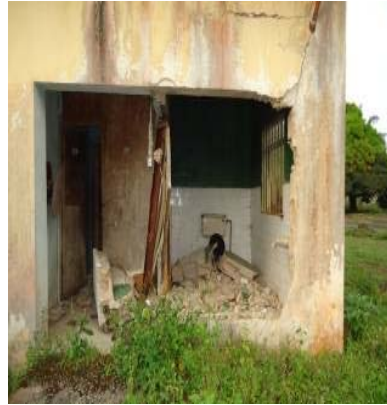
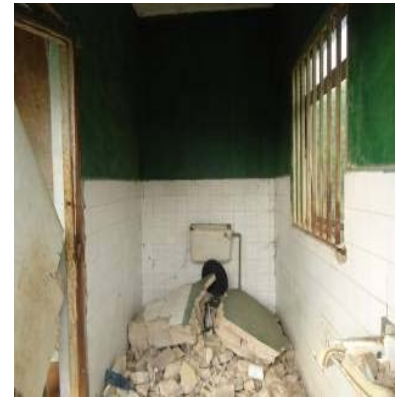
At the time of the visit, the Complex did not look properly kept and appeared to be deteriorating as some of the structures were observed to be fast falling away (Figure 55) with algae growing on some parts of the Complex (Figure 56).

Figure 55: Dilapidated Structures in the Complex

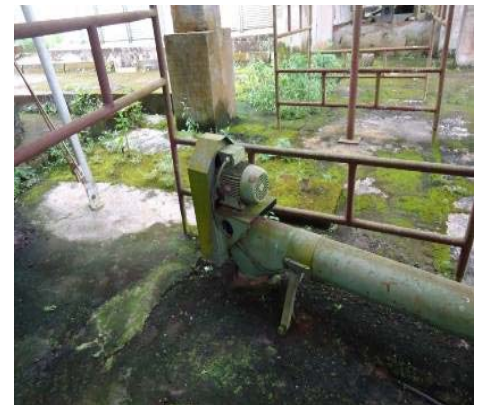
Figure 56: Algae growing on surfaces at the Complex

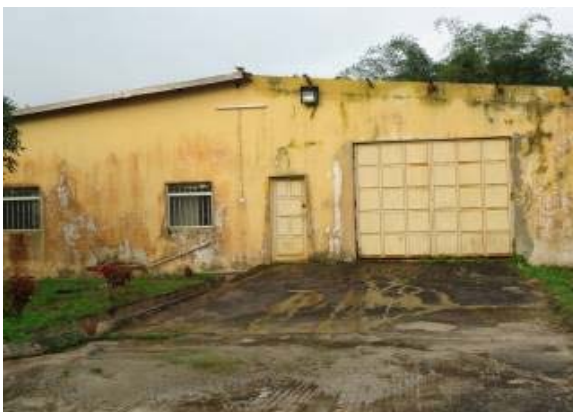
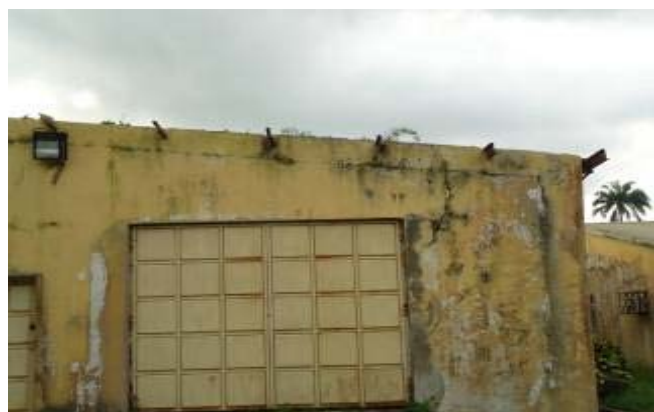
Waste generation in the Complex is relatively minimal as the primary waste (grain waste) is incinerated as soon as they are generated. Waste oil and service parts are indiscriminately disposed, but because the generators are rarely serviced, the immediate effect of this indiscriminate act may not be felt. The noise emanating from the two available generators is also another issue of concern. However, this may not be unconnected with the irregularity in their maintenance. Sections of some buildings were observed to be without roofs (Figure 57). This may either be as a result of faulty construction (roofing) materials or effect of wind gusts on the structures.

Figure 57: Wind Damaged building at the Complex

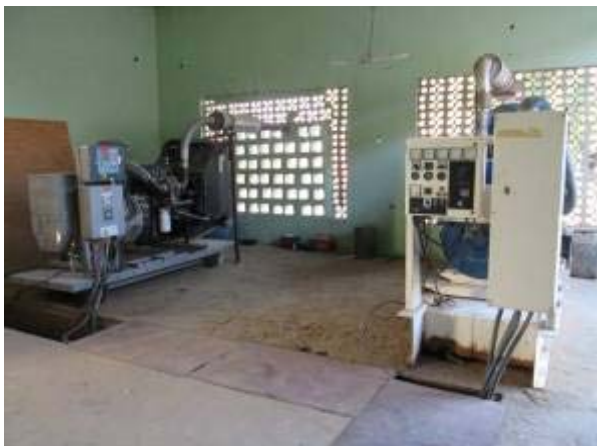
Figure 60: Generator House

Though the Complex has been commissioned over a decade ago, the level of environmental management as observed during the inspection visit seemed to be above average (Figure 61). The maintenance building and the generator house are relatively clean with no form of oil or diesel spill on the floor (Figure 60).

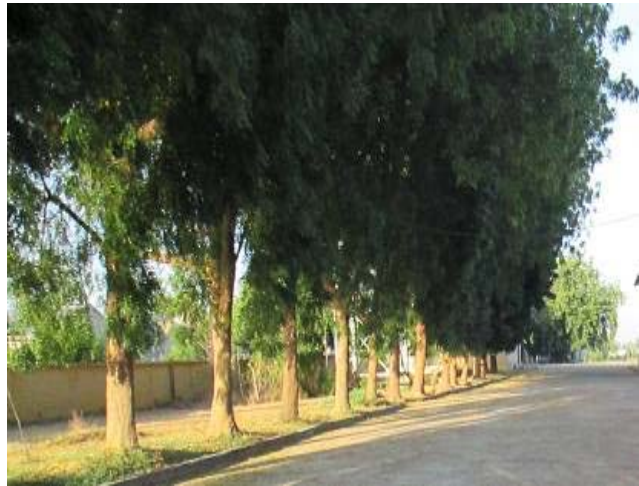
Figure 62: Line of Trees for both Shelter and Wind Break

The Complex is well drained and there are no issues of soil erosion confronting the Complex. There has not been any reported case of wind gust affecting the Silo Complex. This may be as a result of the

trees planted around the Complex, which may have contributed to serving as appropriate wind break for the Complex (Figure 62).

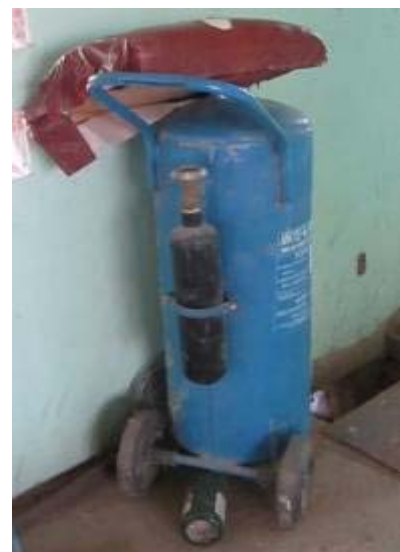
Figure 63: Fire Extinguisher

The complex includes fire hydrants and fire extinguishers (Figure 63). However, it was observed that some of them may require some recharging and upgrade.

Location	Identified Issue/Impact	Mitigation Measure	Estimated Mitigation Cost
Silo Complex	No EIA, non-compliance with environmental laws and regulations related to EIA	Ensure periodic environmental audit every 3-4 years in line with the provisions of the FMEEnv.	N15m/EA study
Silo Complex	Indiscriminate disposal of solid waste (decayed grains), used oil and service parts.	Provide appropriate dump site that is well contained and enforce strict use of the dumpsite. Develop and enforce relevant policies within the Complex. Educate workers against indiscriminate waste burning.	N150,000/waste dump construction. N25,000/waste bin
Silo Complex	Encroachment by local farmers Potential displacement and resettlement of present occupants	Duly consult with affected persons and agree with them on the need to move out of the Silo Complex property. Locate land title documents and ascertain ownership.	
Silo Complex	Fire Extinguishers	Refill	N150,000

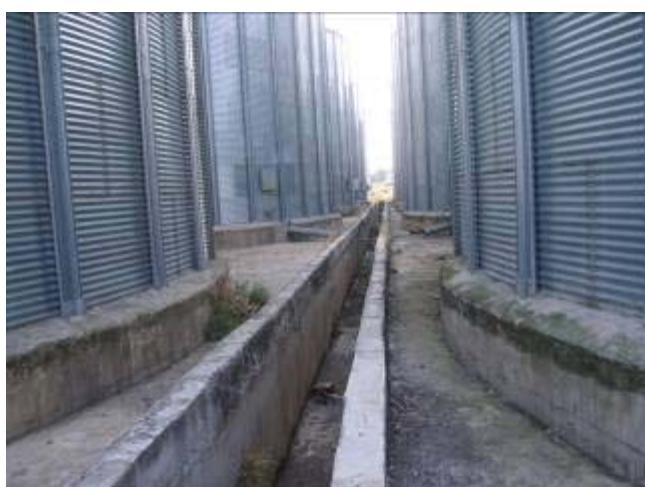
Figure 65: Drainage at Jalingo Silo Complex

Although the Complex is relatively well drained (Figure 64), minor flooding was observed by the main entrance gate, which would need to be addressed before commissioning. This is particularly important as unattended flooding could result in erosion in the near future. Parts of unpaved surrounding are overgrown by grasses (Figure 65).

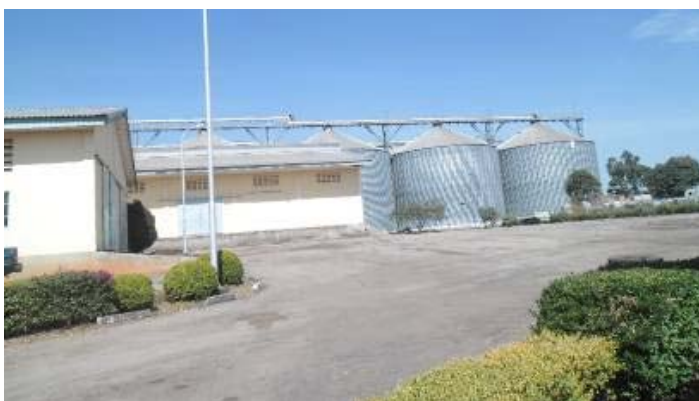
Figure 69: Loading Pad, Admin Buildings and Silo Bins

There is no surface water body in close proximity to the Complex. Therefore, there is no threat of possible pollution of surface water body by the activities of the Silo Complex. Wastes generated are appropriately disposed of. There has not been any issue of soil erosion or wind gust at the Complex. The presence of appropriate drainage and trees around the Complex may have contributed to this (Figure 69).

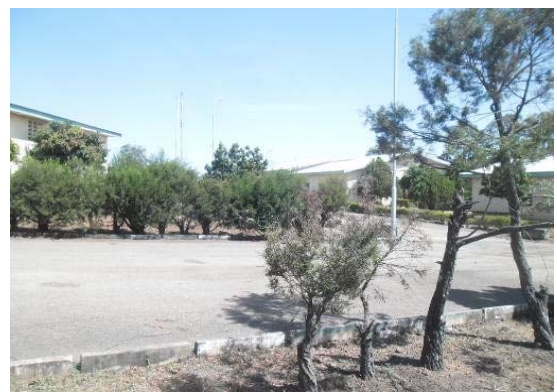
Figure 68: Planted Areas, Jos

The Complex appears to benefit from relatively high environmental management standards as the premises look well maintained with no observed environmental concerns that may have resulted from the operational activities in the Silo Complex (Figure 68). The maintenance building and generator house are also relatively clean with no form of oil or diesel spill on the floor.

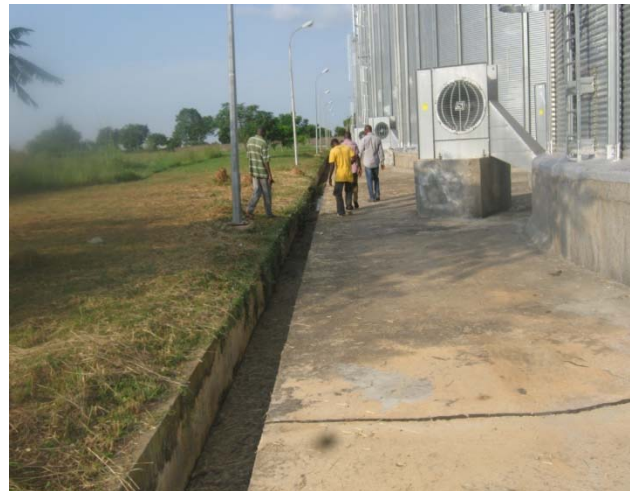
Figure 76: Drainage within Complex

The entire compound is well kept except for the overgrown weeds along parts of the perimeter fence. The Complex is well drained (Figure 76) and there is no form of erosion challenge, wind gust or water damage observed during the complex inspection visit

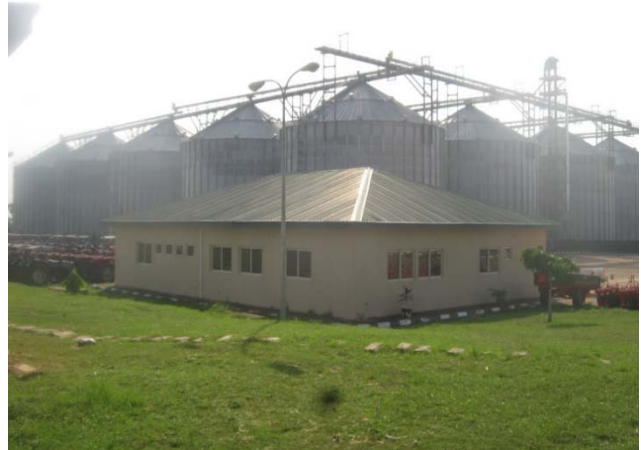
Figure 77: Admin Building, Silo Bins

Only one (1) generator is providing power to the entire silos Complex. Records of maintenance operation carried out on the generator are not available. The generator house is clean and well-kept

with no trace of oil and diesel spill on the floor (Figure 77). The generator noise is not loud enough to cause pollution.

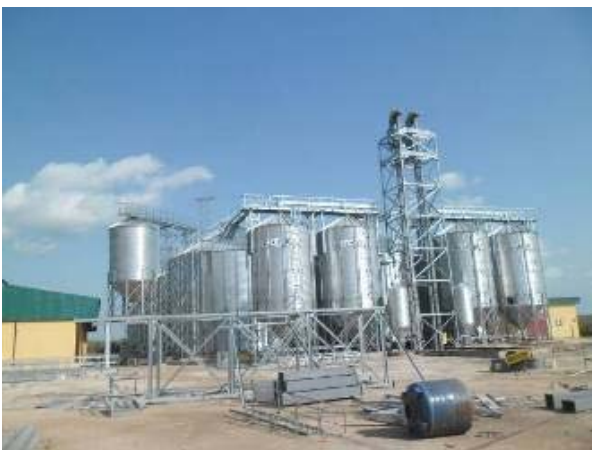
Figure 82: Ongoing Construction at Lafia Silo Complex

There are no environmental concerns which could be attributed to operational activities of the Silo Complex as it is still under construction (Figure 81). While the immediate surroundings of the Complex are well cleared, there are portions towards the perimeter fence with overgrown grasses (Figure 82).

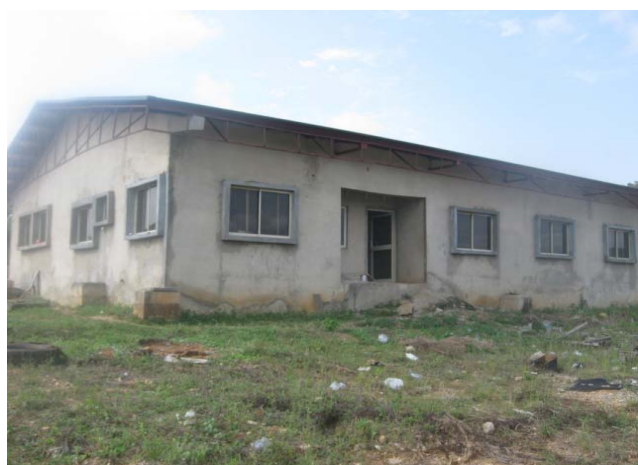
Figure 88: Complex Premises Not Properly Maintained

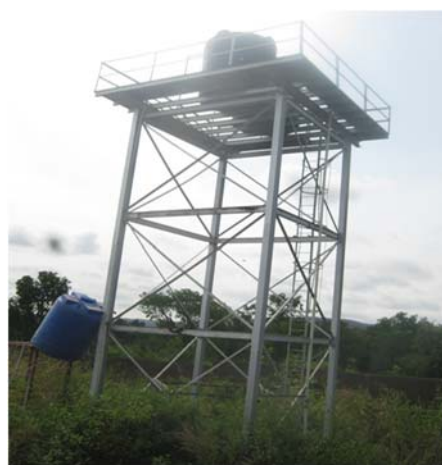
Figure 87: Section of the Complex Overgrown with Bushes

The immediate environment is not well maintained (Figure 87), increasing the risks of reptile and rodent infestation. The immediate area of the perimeter fence is overgrown with bushes (Figure 88).

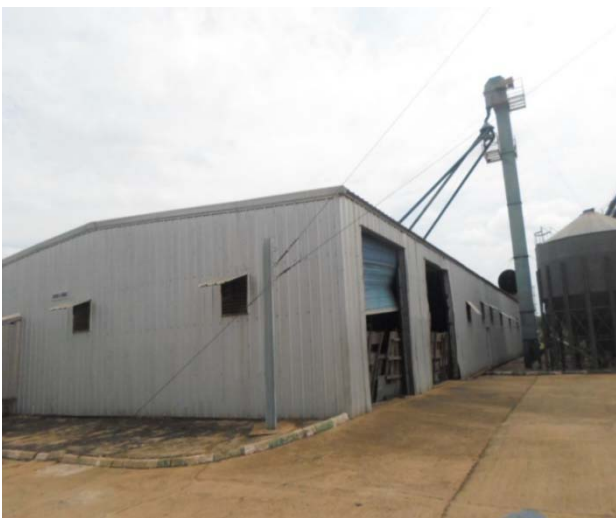
Figure 92: Storage Facility

There is no significant noise from the generator operation and no spillage of oil or diesel (Figure 92). Chemicals used including fumigant, coopex dust, phostozin and are stored in pallets about 10 metres from the administrative block.

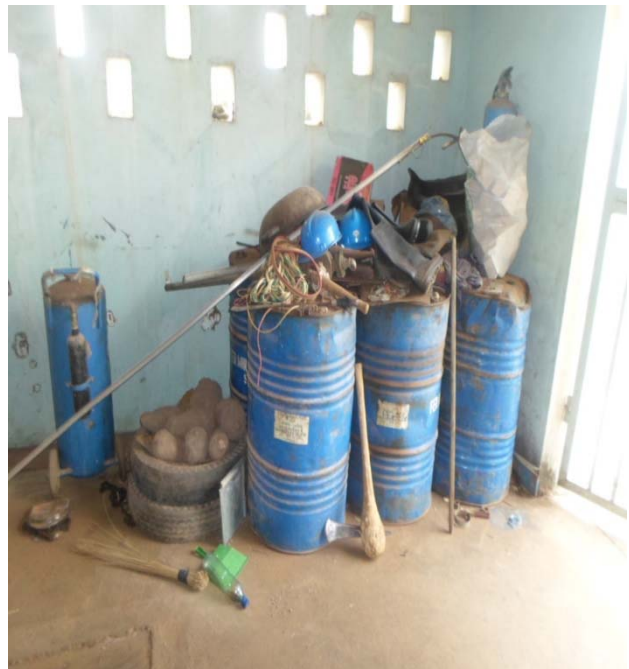
Figure 94: Some PPE Available at the Complex

The Complex employs 17 staff. Workers are provided with adequate personal protective equipment (PPEs) although compliance to basic HSE standards is not strictly enforced. The PPEs that are used in the Complex include dust respirator, chemical respirator, helmets, hand gloves, goggles, safety boots and rain boots (Figure 94). No accident that resulted in loss time injury has been recorded by the Silo Complex. However, health problems resulting from the use of chemicals have been reported. There is no sick bay or clinic in the Complex to deal with medical emergencies. The Complex includes fire hydrants and fire extinguishers. Fire extinguishers need to be serviced.

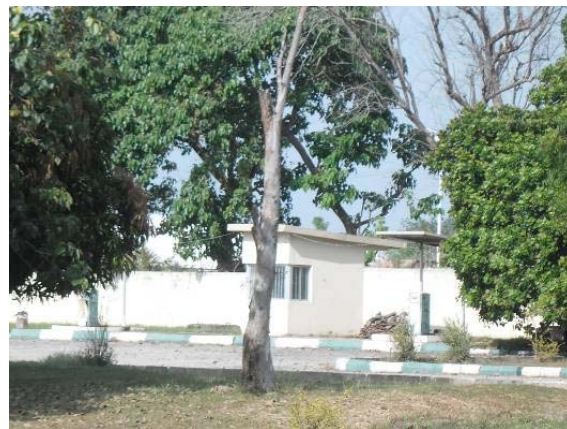
Figure 98: Planted area and Admin Building

A number of trees are planted within the Complex to provide shelter and serve as appropriate wind breaks for the Silo Complex (Figure 98).

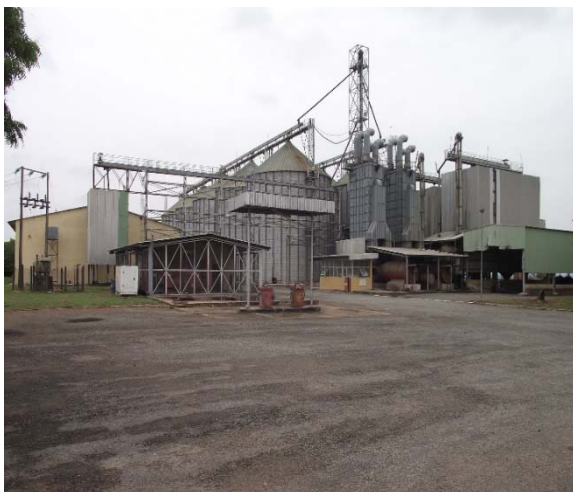
Figure 101 Silo Bins, Generator House

The Complex premise is properly maintained and no issue of environmental concern was observed in the external areas (Figure 101, Figure 102). No significant noise was noticed from the generator operation and there was no spillage of oil or diesel near the generator area.

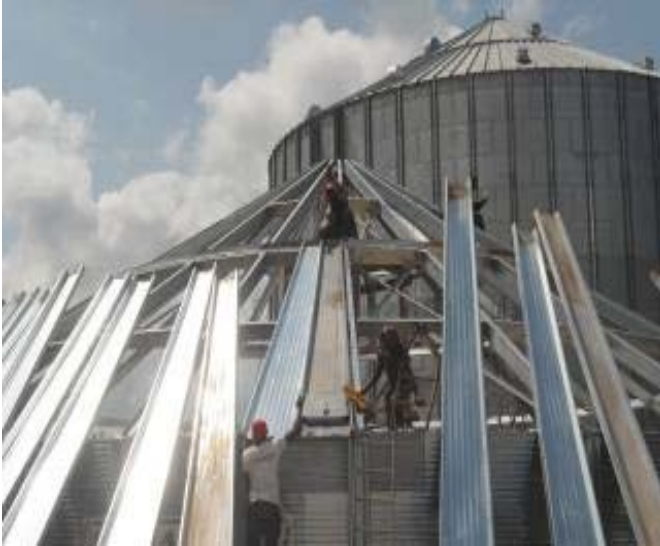
Figure 104: Ongoing construction at Okigwe Silo Complex

The Okigwe Silo Complex is located in Ezinachi in Okigwe Local Government Area. It is still under construction (Figure 103, Figure 104) and is expected to have a storage capacity of 100,000MT when completed.

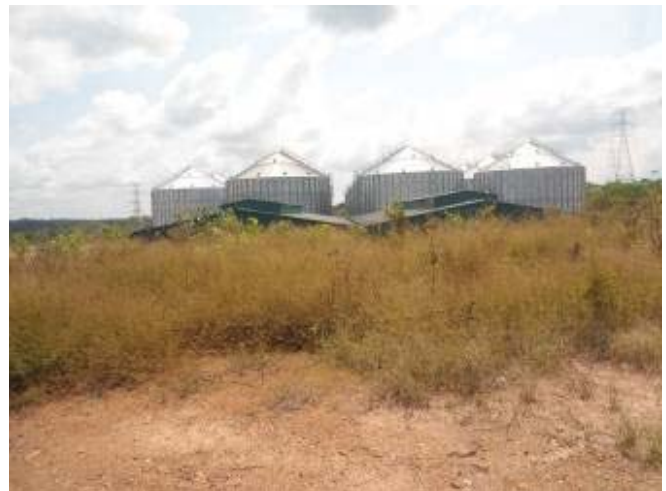
Figure 105: Overgrown Brush Areas at Okigwe Silo Complex

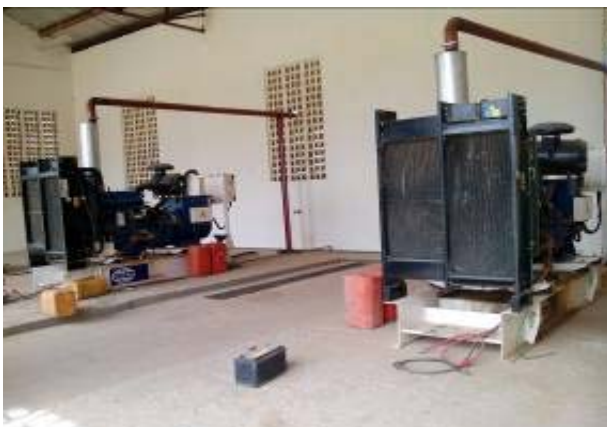
Figure 108: Generator House, Sokoto

The generator house is kept clean and tidy (Figure 108). The grain storage facility has not experienced problems of erosion or wind gust. Figure 109 shows trees planted around the Complex to serve as

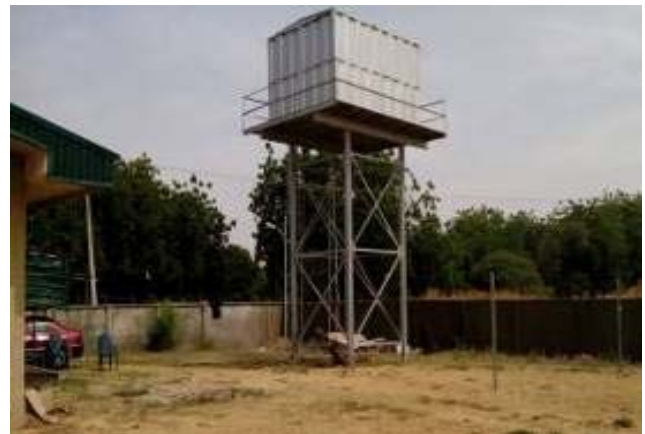
Figure 109: Planted Areas, Sokoto

wind break to ensure problems do not arise in the future as a result of wind gust. There is no significant noise impact from the generators' operations.

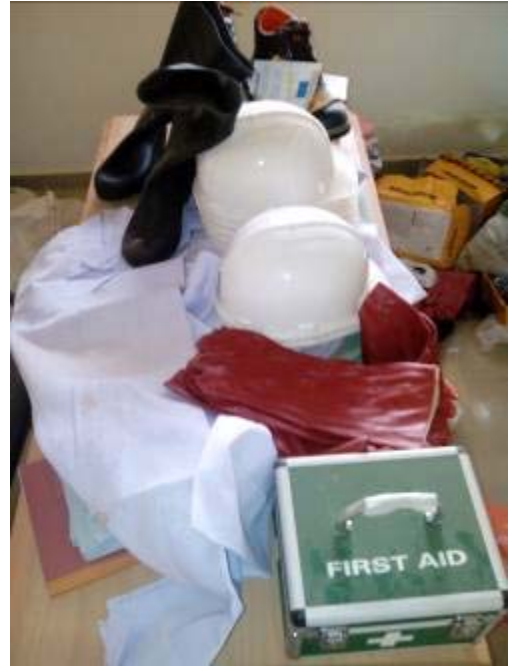
Figure 110: PPEs on Display, Sokoto

The Complex employ 7 staff. The workers are provided with adequate PPEs and HSE standards are enforced (Figure 110). Chemicals are stored in a wardrobe at the maintenance house and there are yet no serious health related problems recorded among the workers resulting from the use of these chemicals. Trainings have been conducted for staff on the handling of these chemicals.

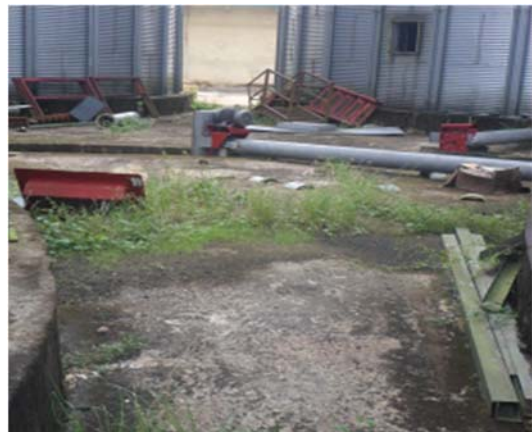
Figure 114: Construction Materials, Uyo

There are no environmental concerns which could be attributed to operational activities of the Silo Complex as it is still under construction (Figure 113, Figure 114).

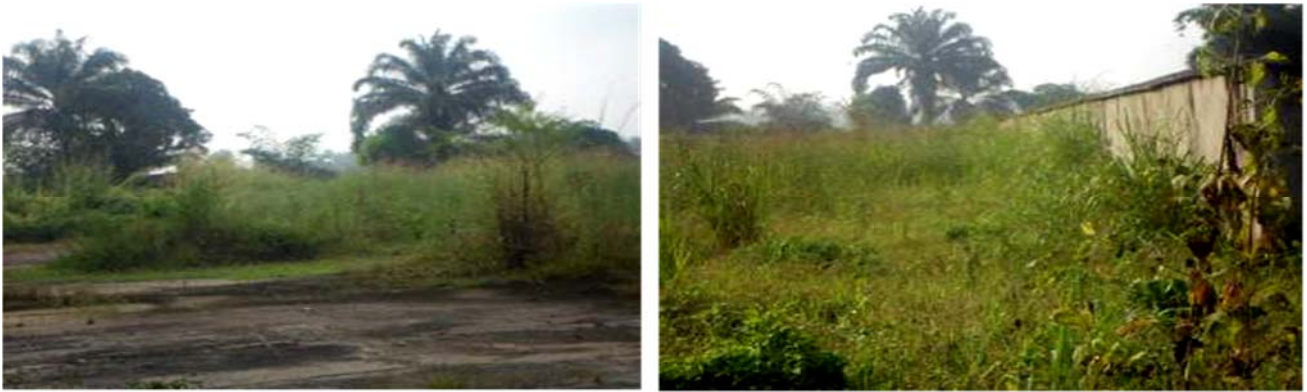
There is a surface water body located near the Complex. The immediate surroundings of the Complex are not regularly maintained. Portions towards the perimeter fence show overgrown grasses (Figure 115).

Figure 115: Perimeter Areas, Uyo

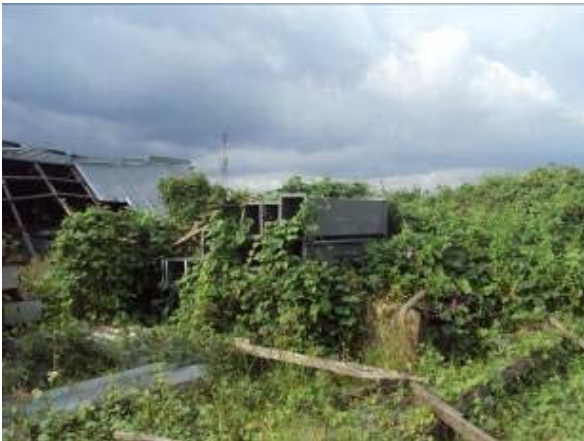
Figure 118: Stacked Construction Materials, Yenagoa

It is worth noting however that the location is presently overgrown and the construction materials, which were brought on site some time ago, are covered with weed (Figure 117, Figure 118).

The present overgrown condition of the Complex may engender some environmental risks such as presence of reptiles, which could be hazardous to workers.
