CONCESSION OF 33 SILO COMPLEXES IN NIGERIA

DUE DILIGENCE REPORT- VOLUME B

TECHNICAL DUE DILIGENCE

March 2015

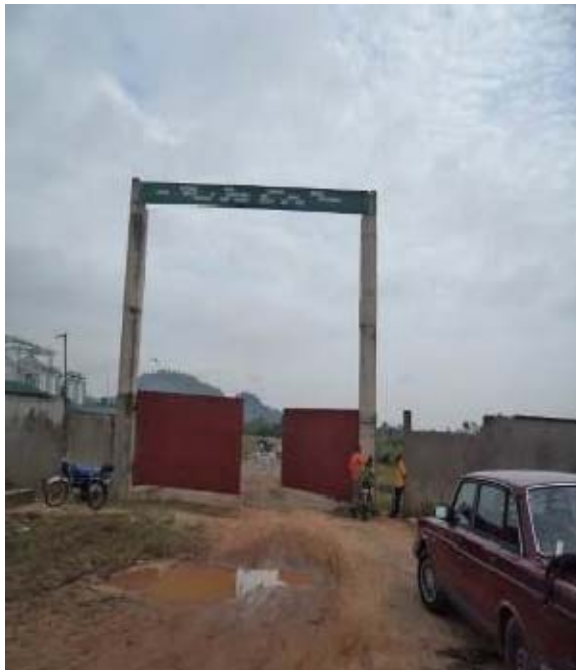
Photo 1: Untarred Entrance Access Road

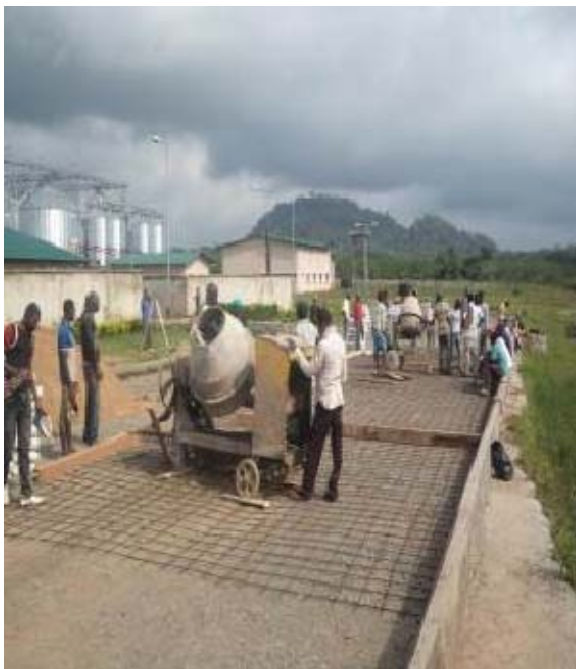
Photo 3: On-Going Construction Of Pavement

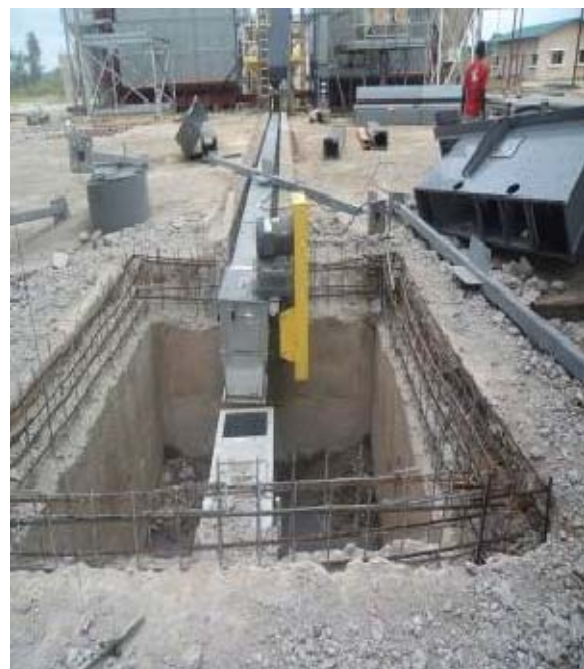
Photo 4: On-Going Construction Of Elevators Pit

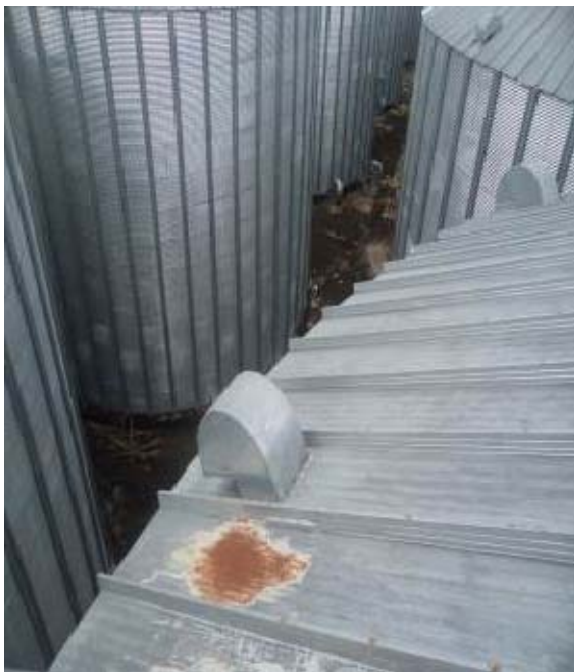
Photo 11: Rust On Section Of Bin Roof Cover

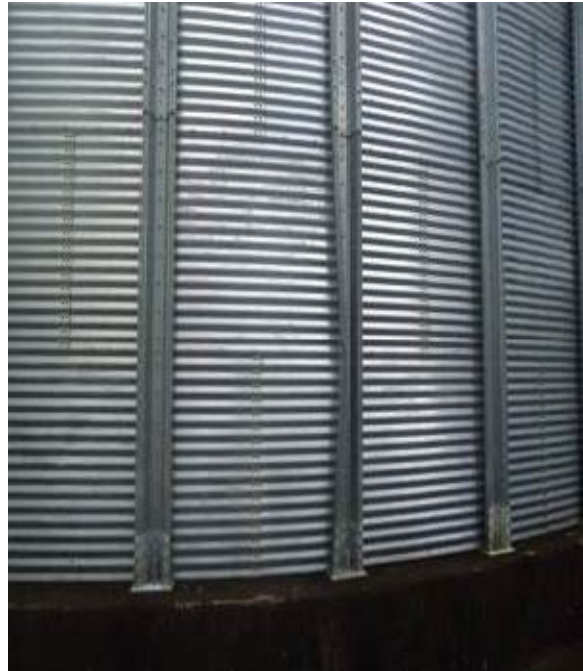
Photo 14: Damage Bin Sheet Station

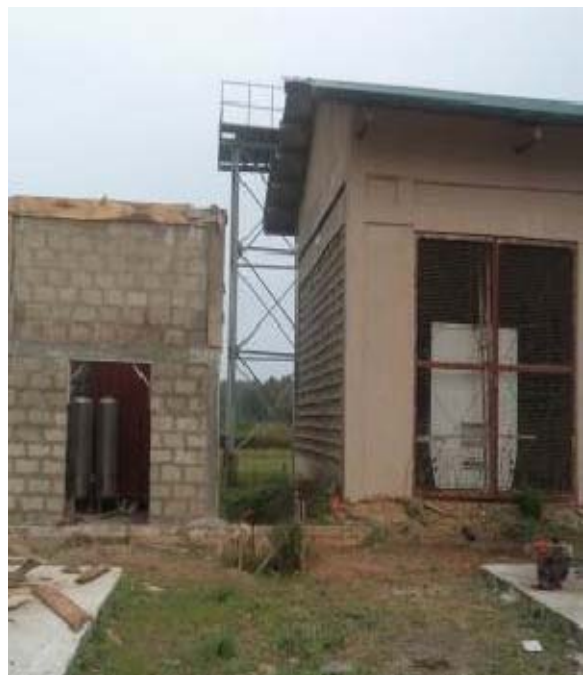
Photo 16: On-Going Construction Of Water Treatment Plan

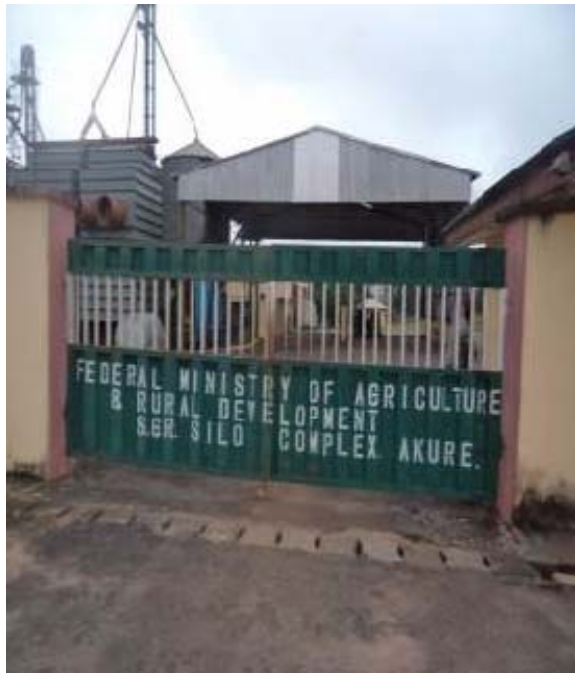
Photo 17: Akure Silo Complex Tarred Entrance Access Road

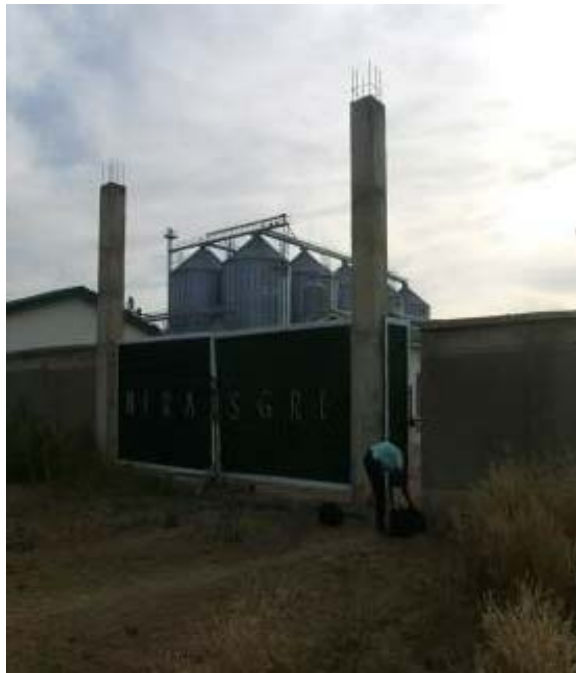
Photo 33: Bauchi Silo Complex Untarred Entrance Road

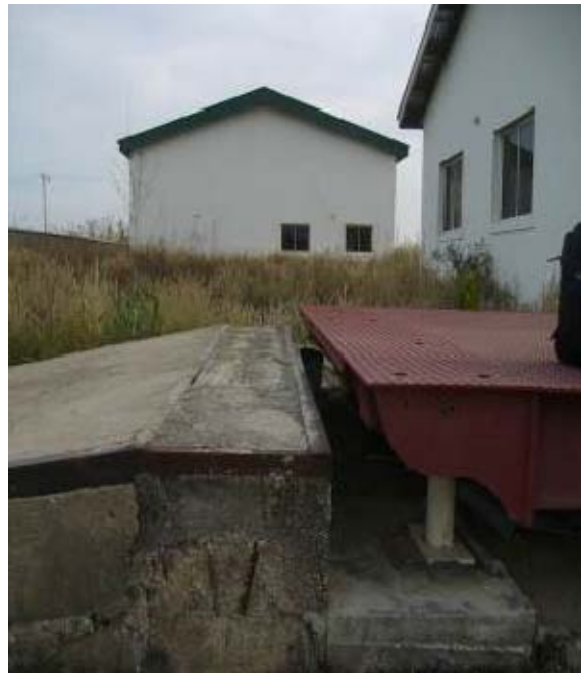
Photo 34: Unaligned Ramp With Weigh Bridge Platform

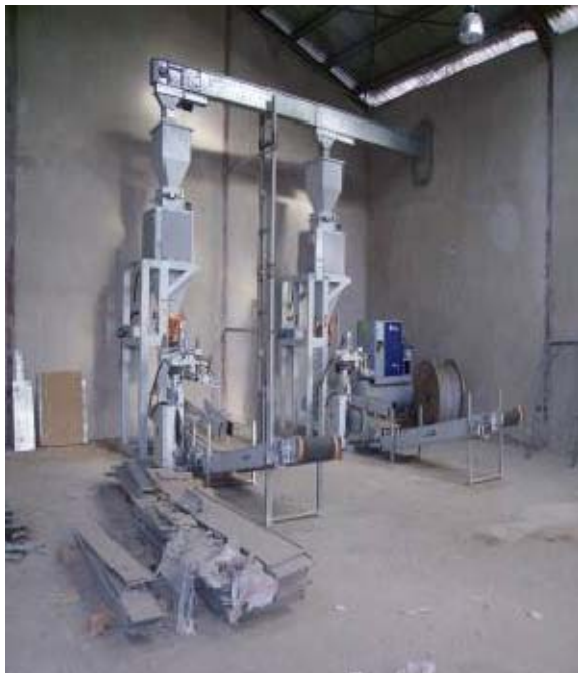
Photo 39: Installation Of Bagging Plant On-Going

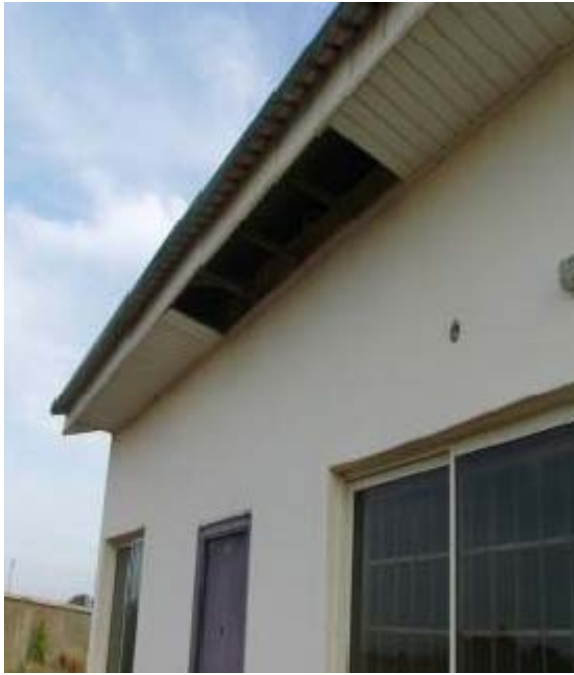
Photo 41: Section Of Uncompleted Roof Ceiling

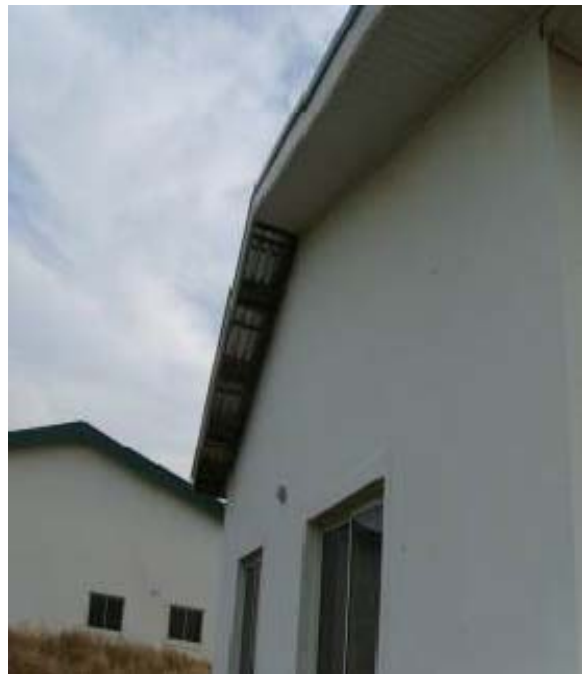
Photo 42: Section Of Uncompleted Roof Ceiling

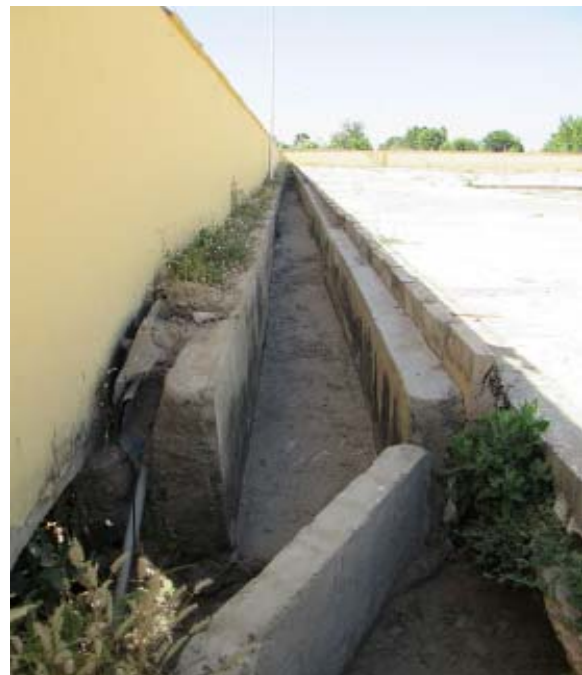
Photo 93: Bad Drainage System

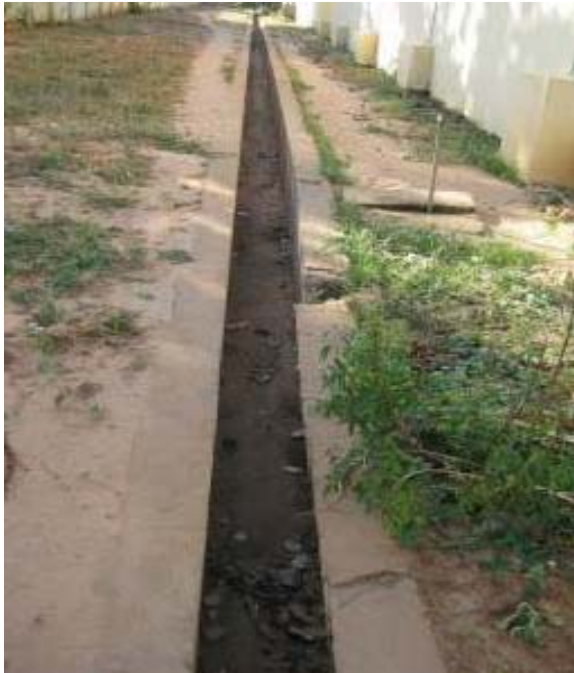
Photo 114: Dilapidated Drainage

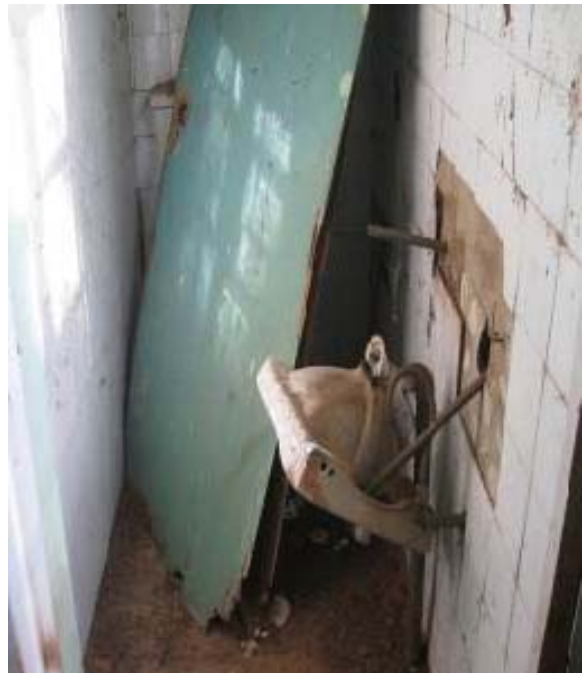
Photo 115: Bad Rest Room

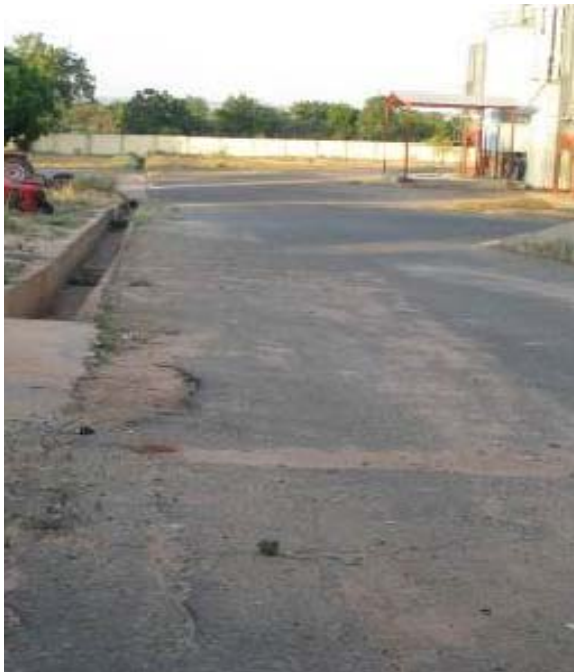
Photo 116: Dilapidated Internal Road Network

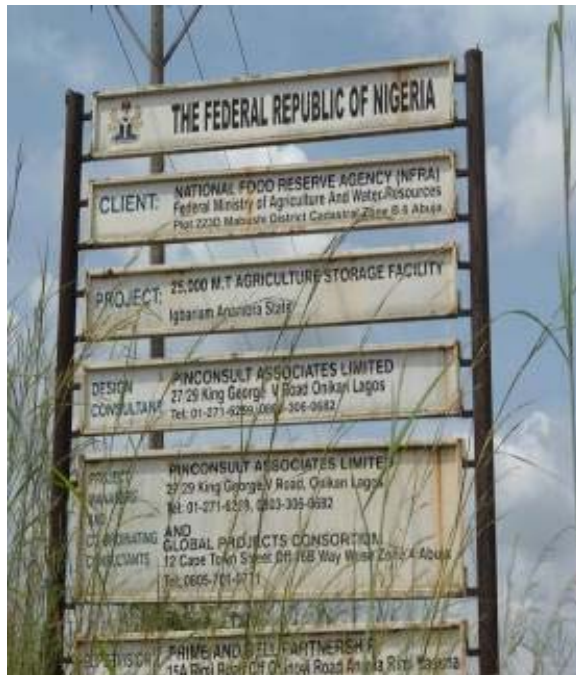
Photo 144: Igbariam Silo Complex Under Construction

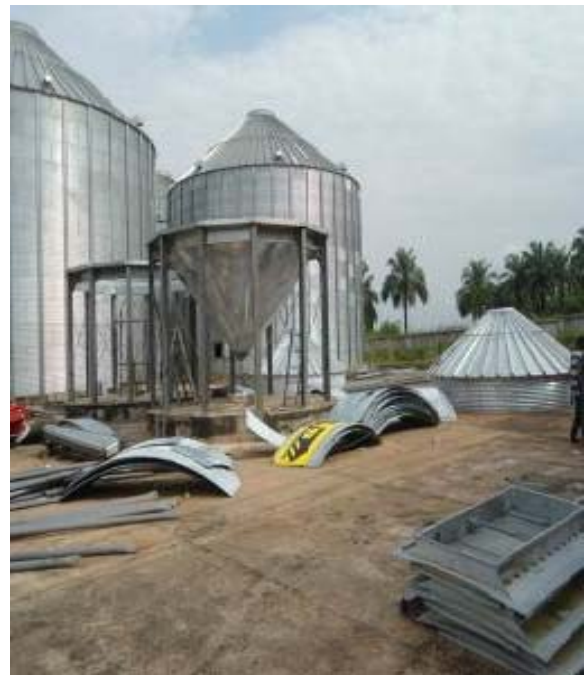
Photo 145: Installation On-Going

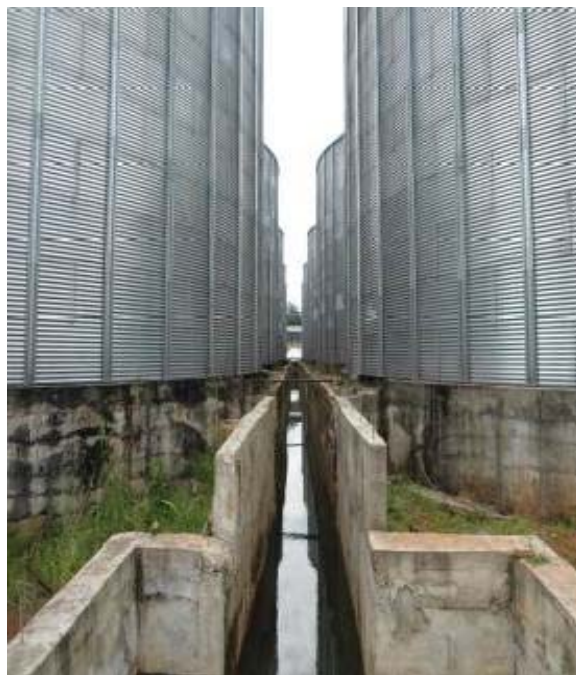
Photo 146: Installed Silo Bins

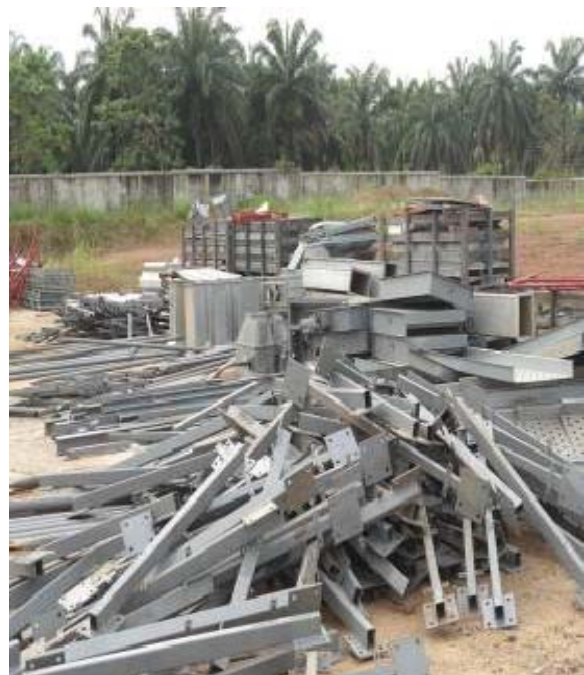
Photo 147: Silo Components Installation On-Going

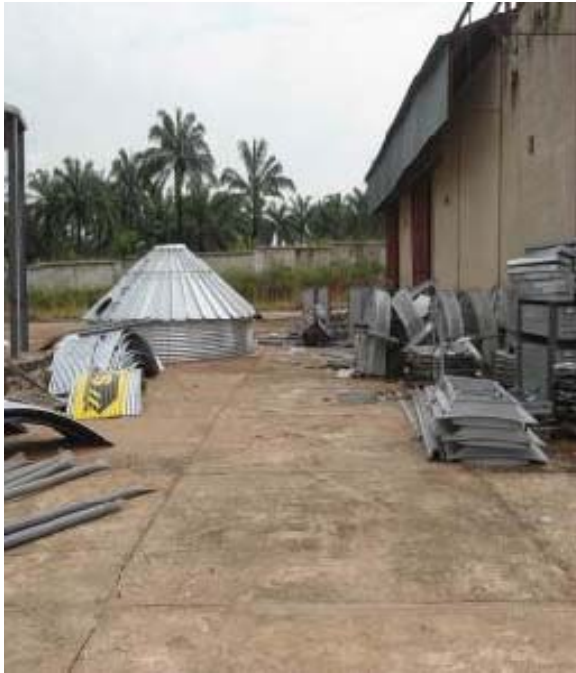
Photo 148: Silo Components Installation On-Going

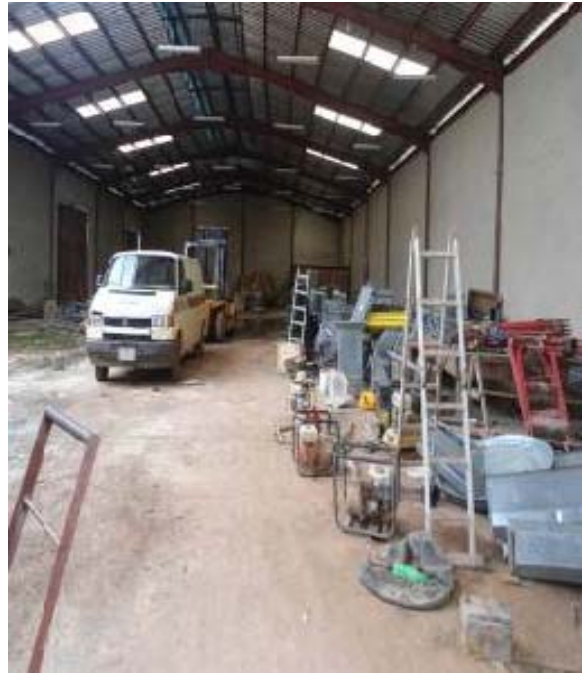
Photo 149: Silo Components Stored In Warehouse

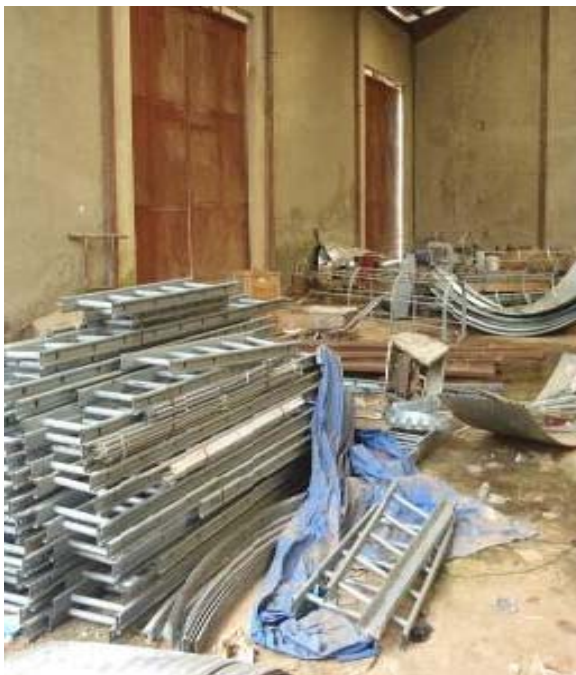
Photo 150: Silo Bins Cat-Ladders Installation On-Going

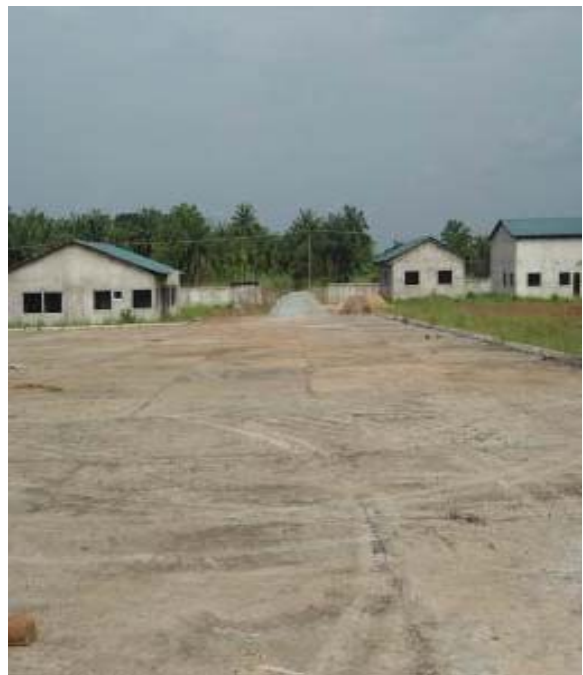
Photo 151: Construction Of Ancillary Structures On-Going

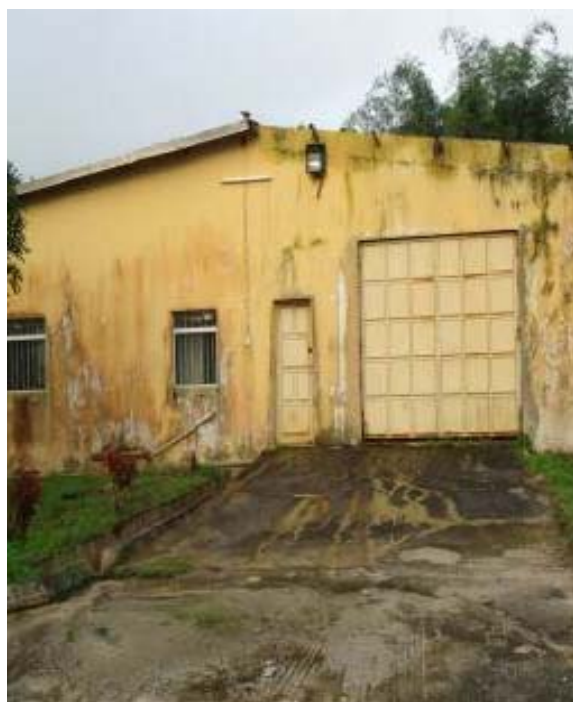
Photo 202: Blown - Off Roof Covers

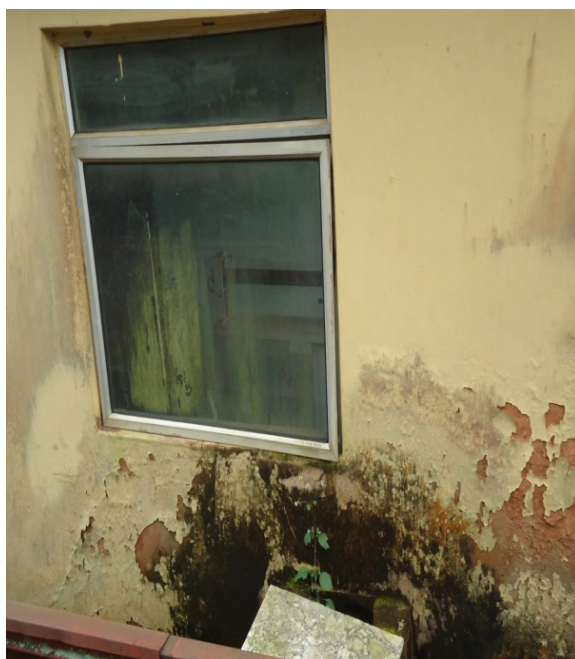
Photo 216: Building Wall Affected By Dampness

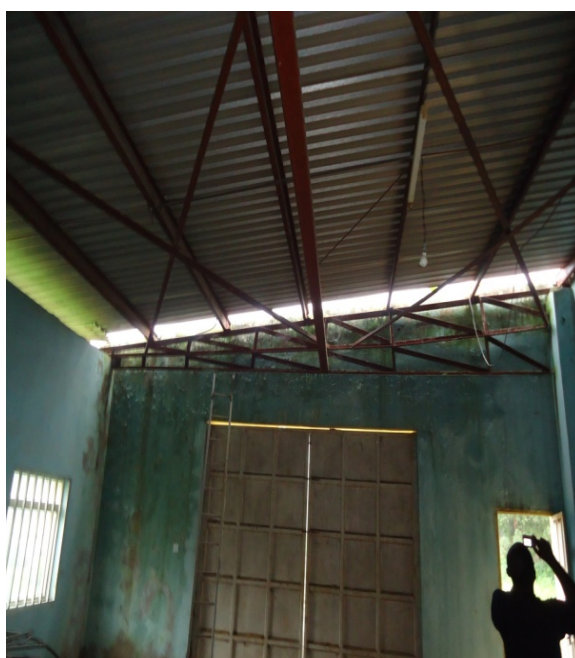
Photo 222: Section Of Blown-Off Roof Cover

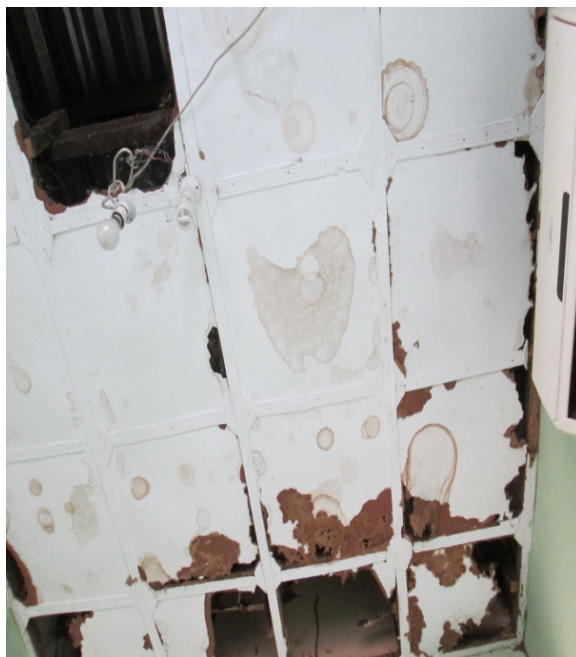
Photo 228: Deteriorating Roof Ceiling

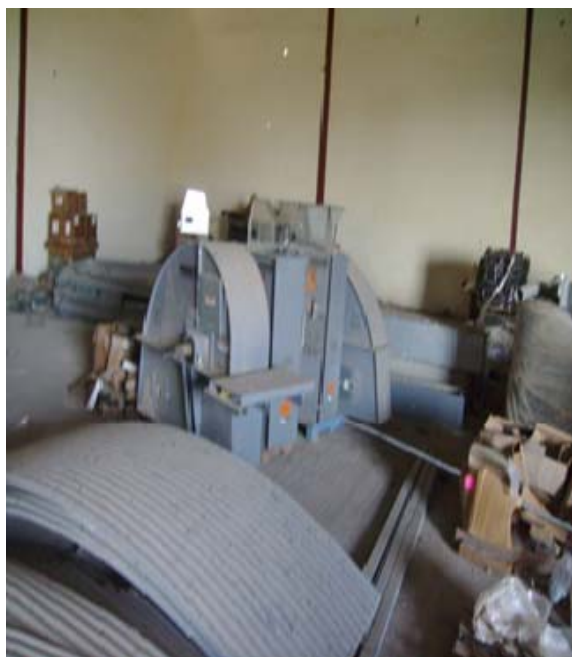
The assessment of the condition of the equipment and infrastructure is presented in Annex C. Major Mechanical, Electrical installation of the silo equipment and civil works are on-going. The utilization potential of this Complex is 8%.

Photo 236: Silo Components Installation On-Going

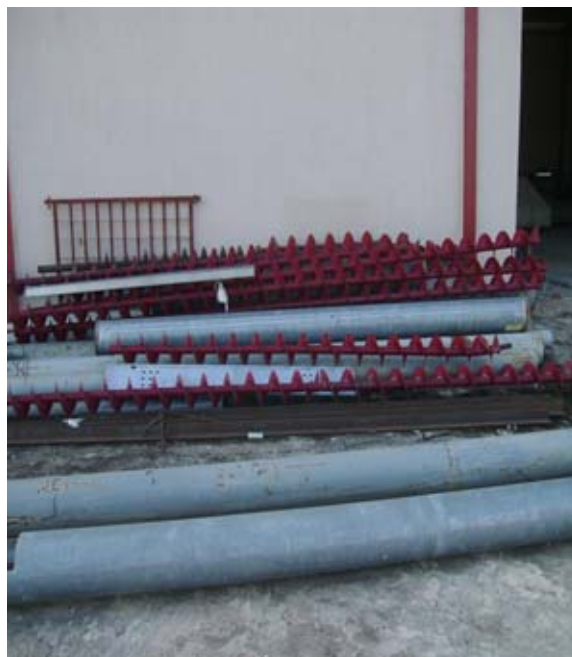
Photo 238: Silo Components Installation On-Going

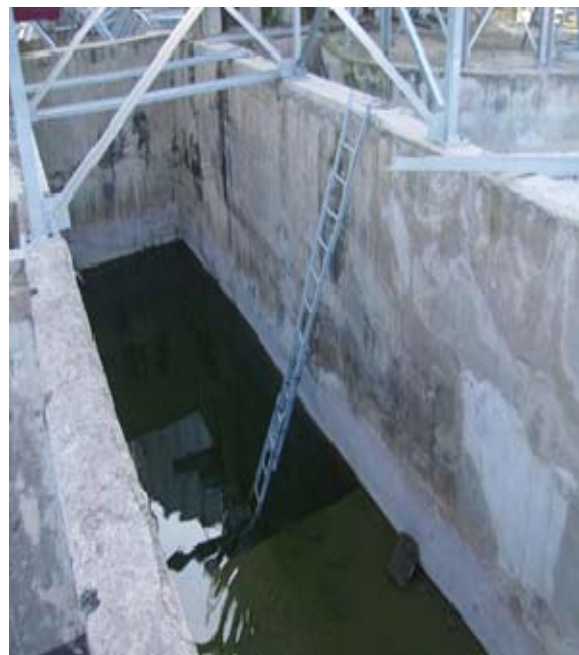
Photo 242: Water Seepage In Elevators Pit

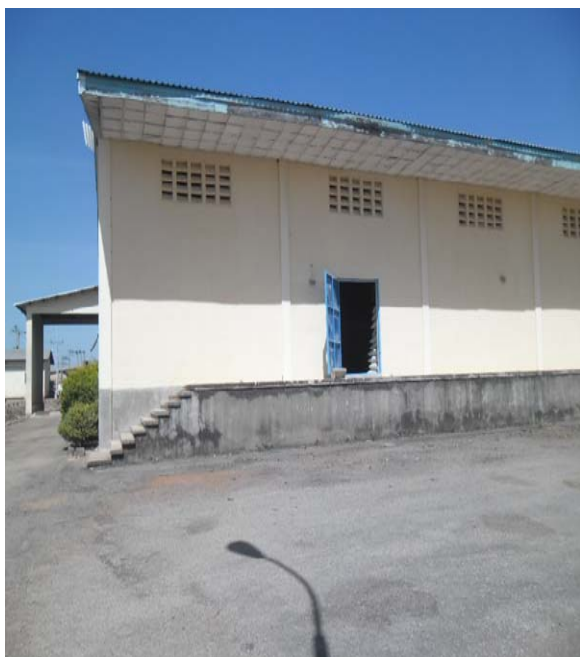
Photo 251: Deteriorating Facial Board

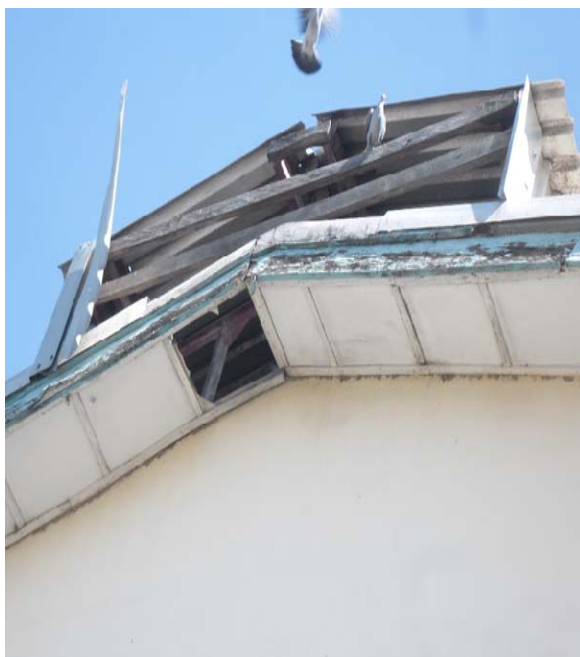
Photo 253: Deteriorating Facial Board

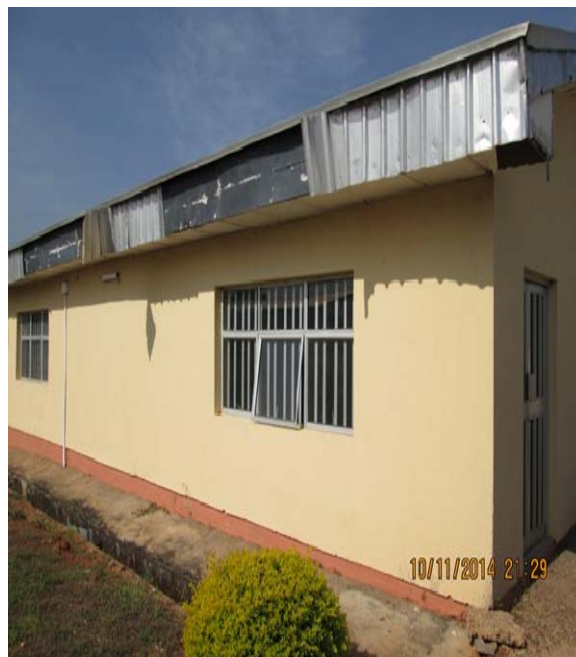
Photo 260: Damaged Roof Cladding

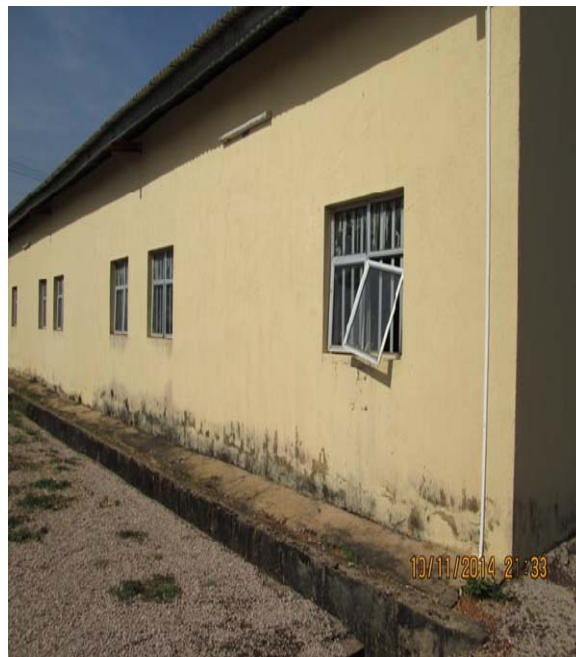
Photo 262: Damaged Warehouse Windows

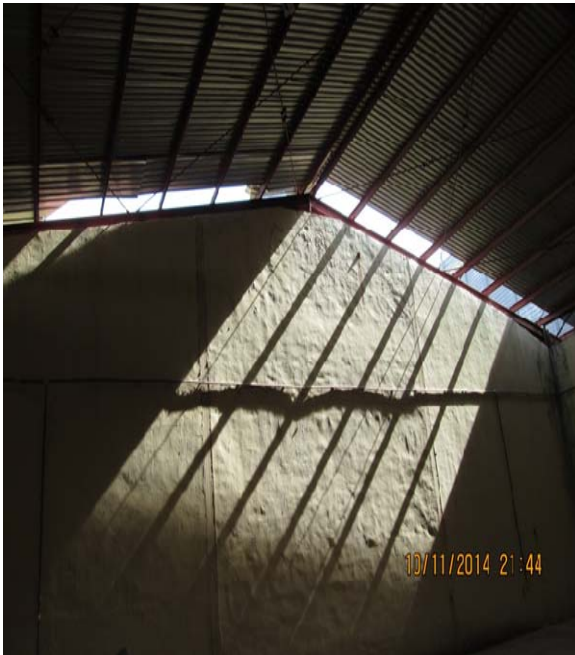
Photo 263: Warehouse Blown-Out Roof Covers

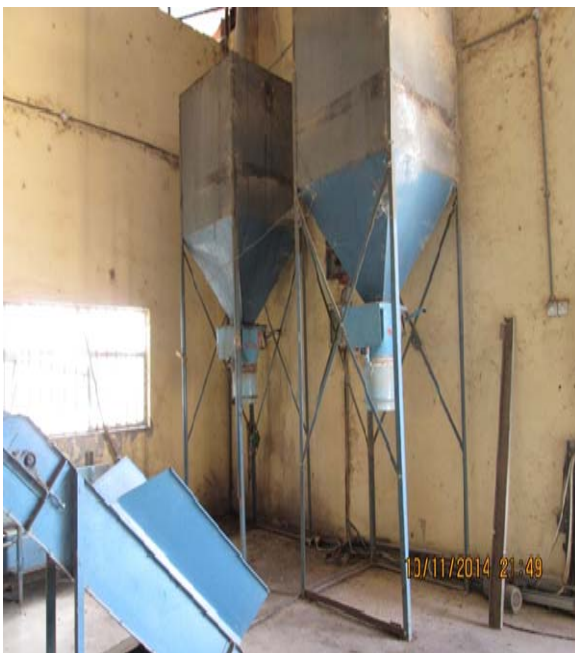
Photo 265: Faulty Bagging Plant

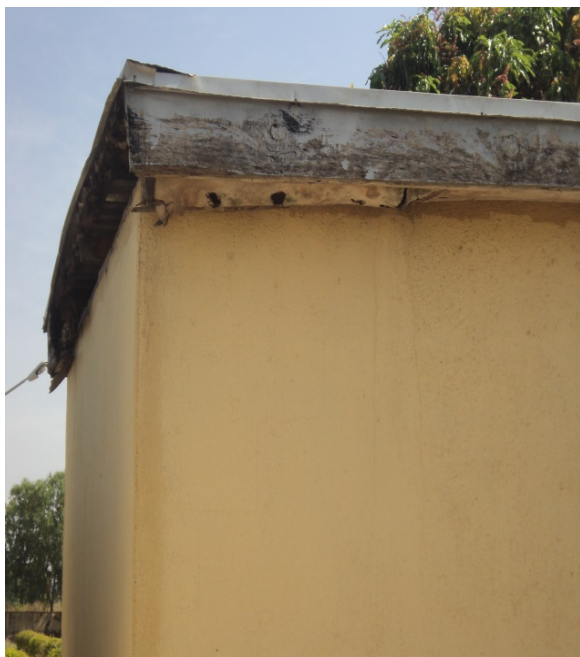
Photo 271: Security Gate Post Damaged Roof Facial Board

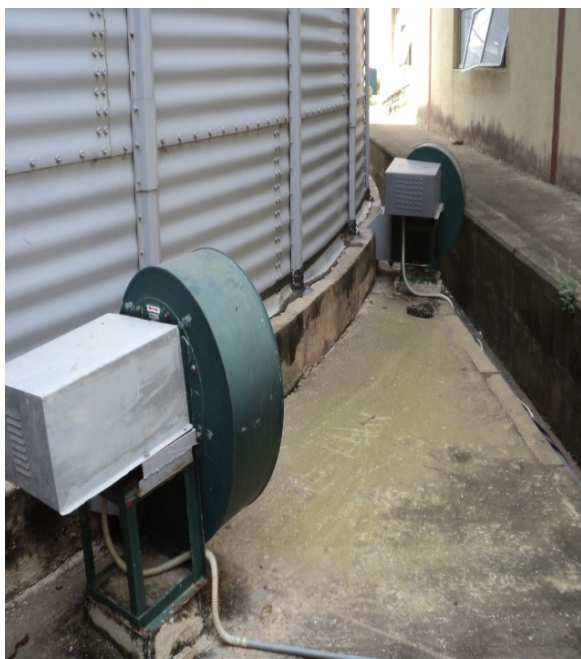
Photo 277: Faulty Centrifugal Aerators

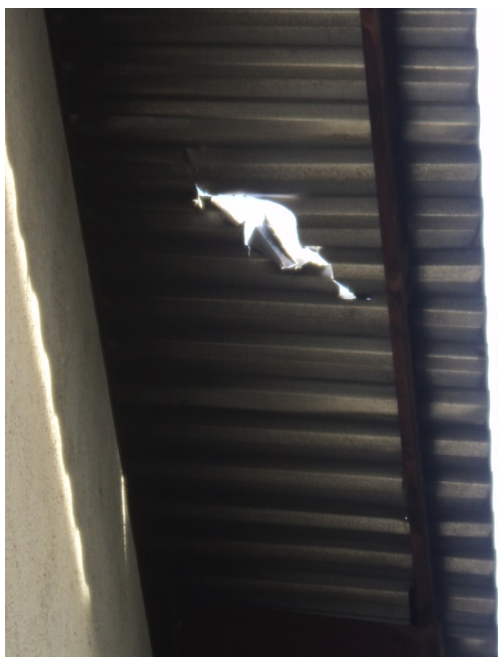
Photo 281: Small Hole On The Warehouse Roof Cover

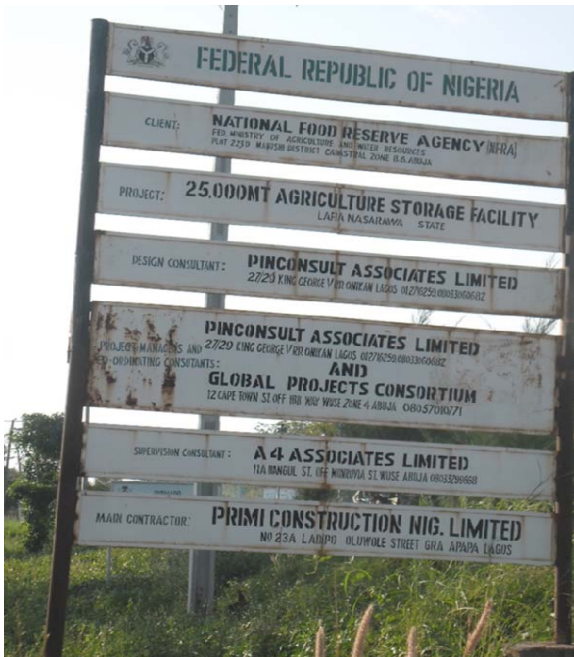
Photo 290: Lafia Silo Complex Construction On-Going

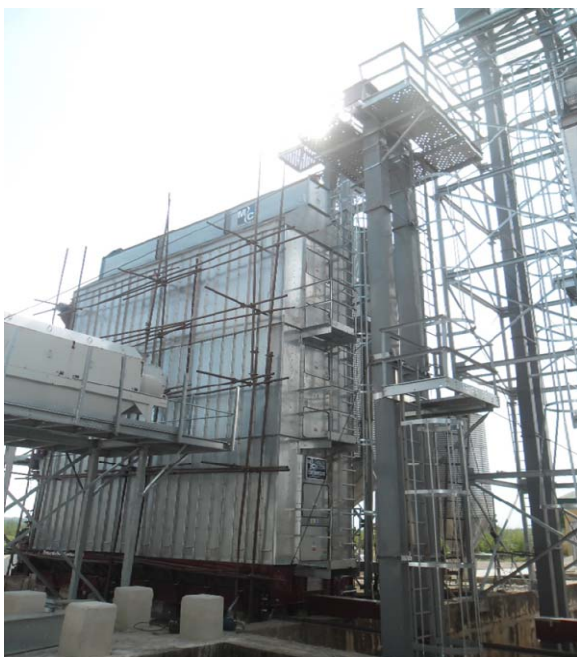
Photo 296: Installation Of Grain Dryer On-Going

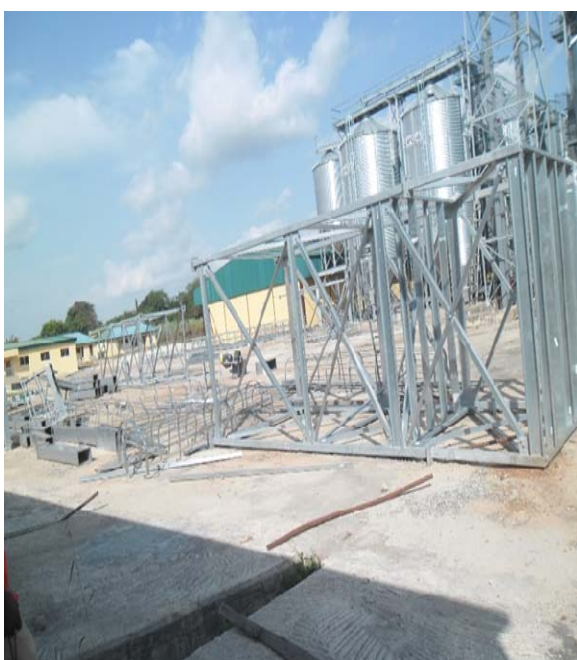
Photo 300: Silo Components Installation On-Going

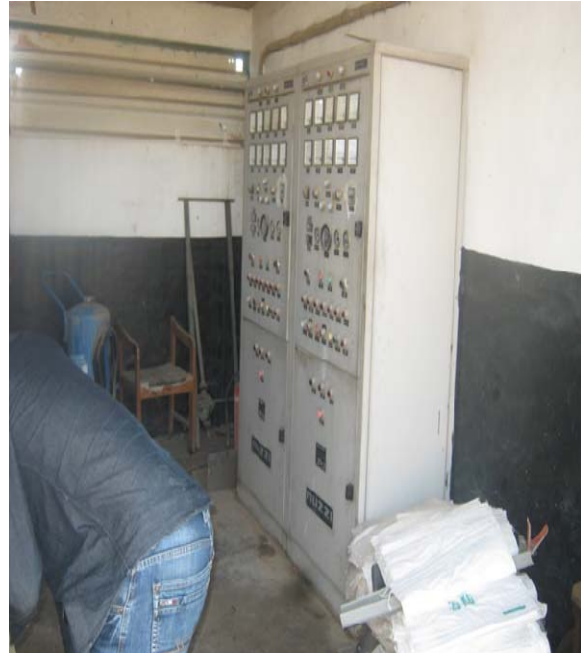
Photo 306: Control Panel

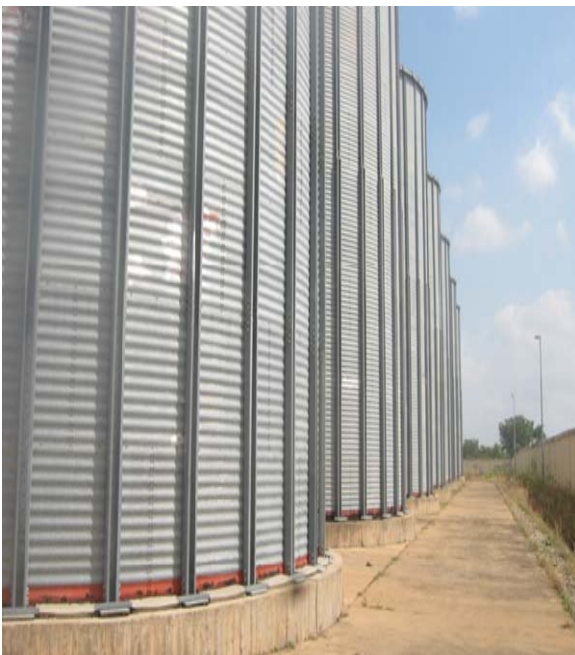
Photo 307: Silo Bins

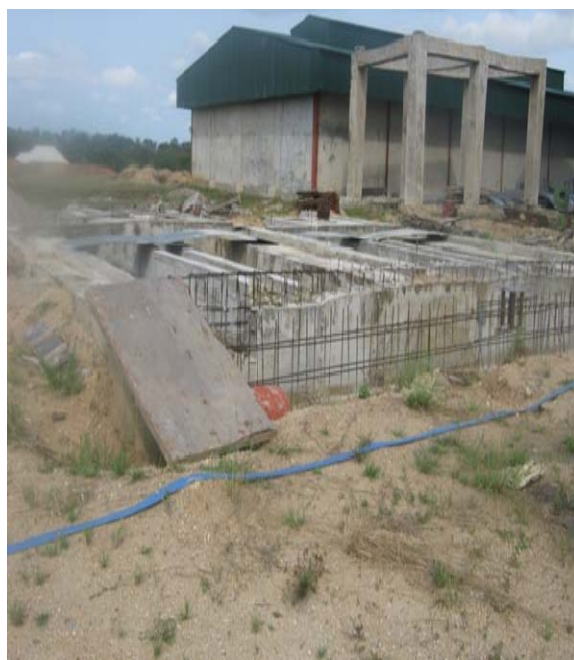
The assessment of the condition of the equipment and infrastructure is presented in Annex C. All mechanical and electrical installations of the silo equipment present, as well as all civil structures are still on-going. Workshop tools, laboratory equipment and fire extinguishers need to be provided. The utilization potential of this Complex is 17%.

Photo 311: Construction On-Going

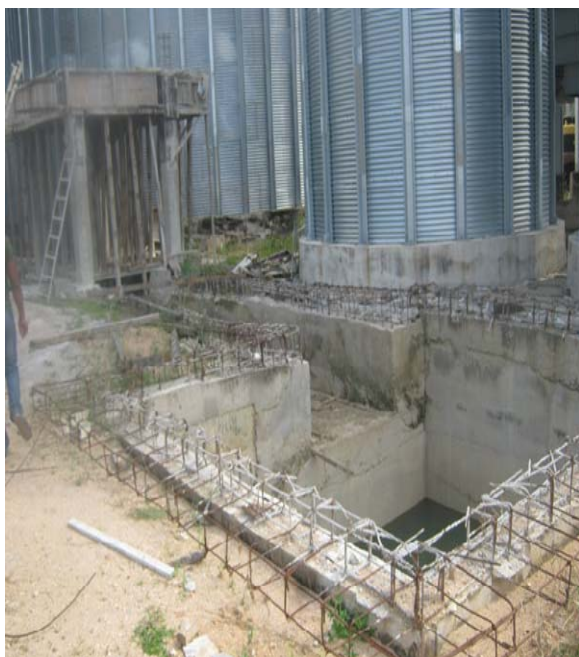
Photo 312: Elevators Pit Construction On-Going

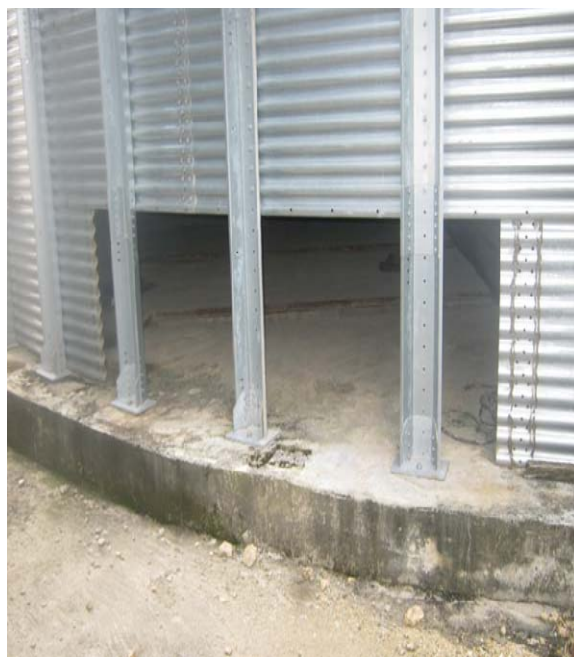
Photo 315: Silo Galvanized Wall Sheet Installation On-Going

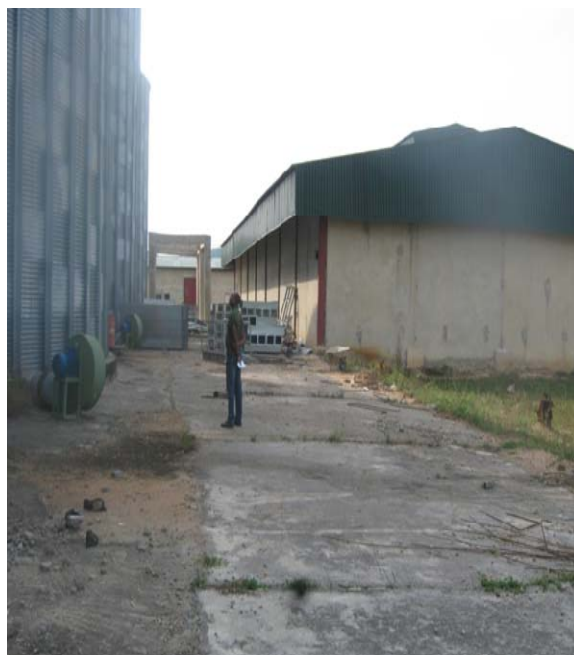
Photo 319: Unpaved Internal Road Network

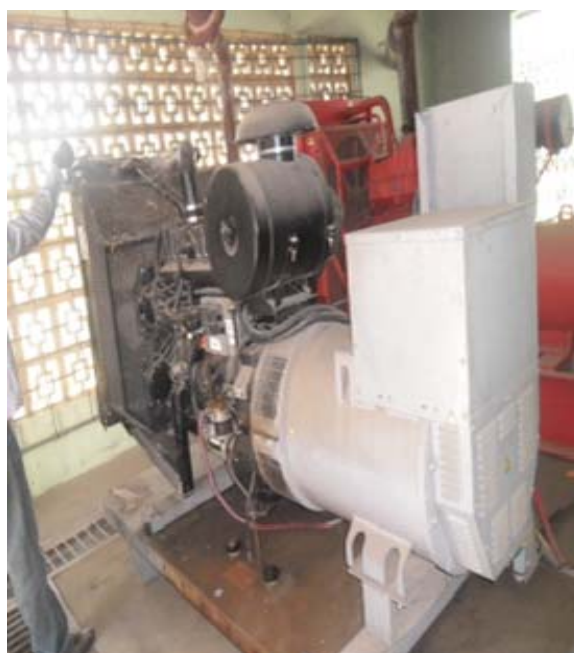
Photo 337: Generator

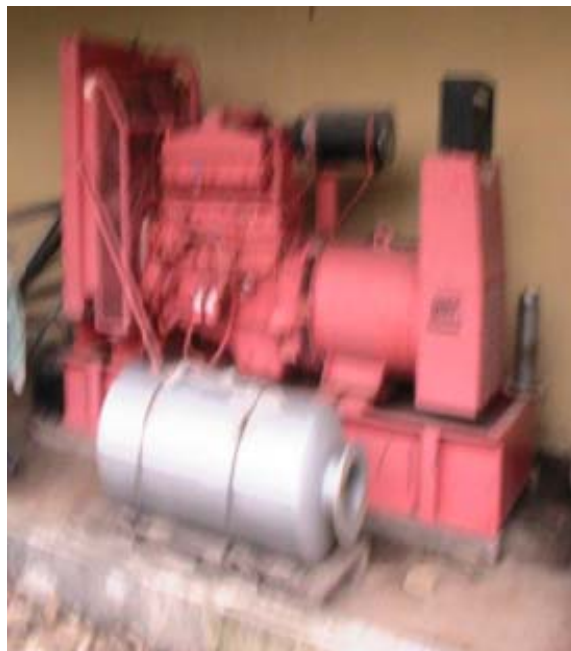
Photo 345: Generator

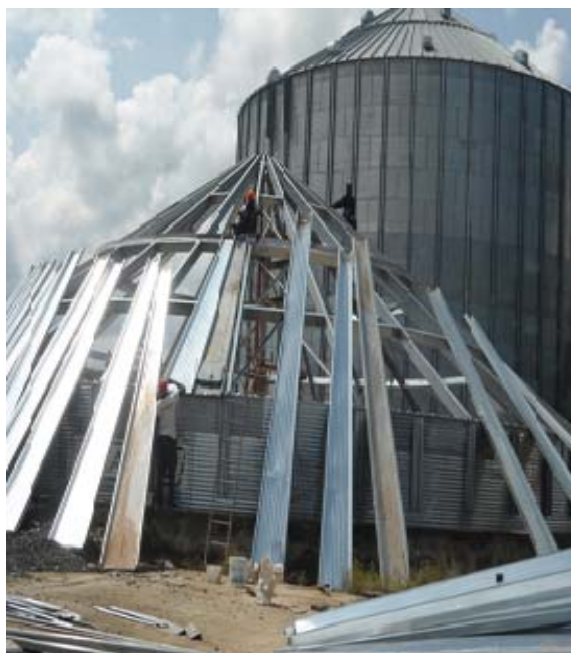
Photo 353: Installation Of Silo Bin Roof Cover

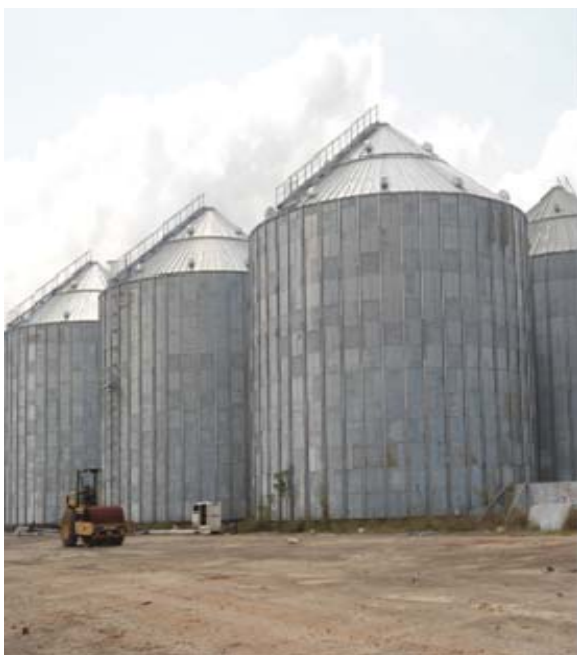
Photo 354: Installation Of Silo Bins On –Going

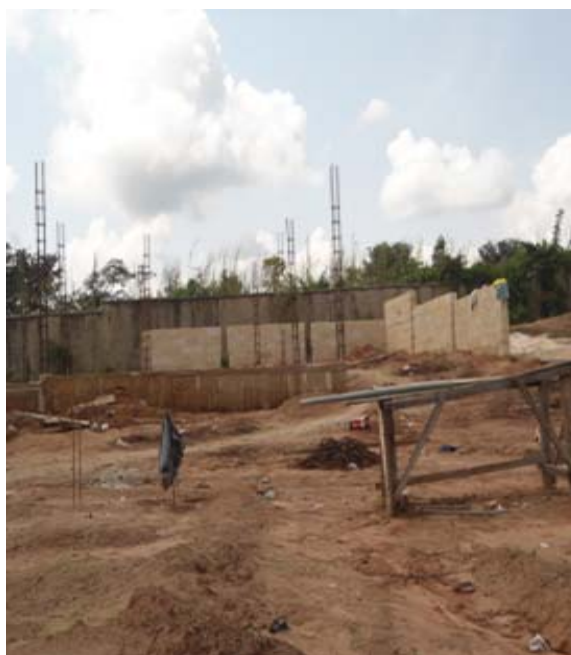
Photo 355: Civil Works Construction On-Going

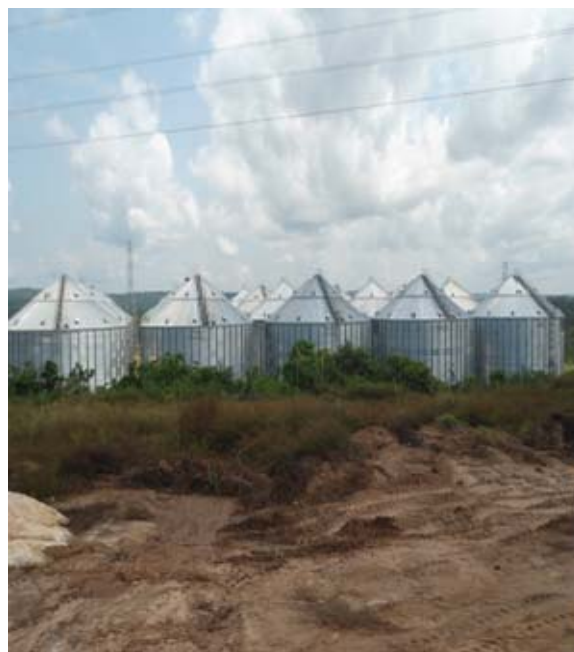
Photo 359: Silo Complex Site Under Construction

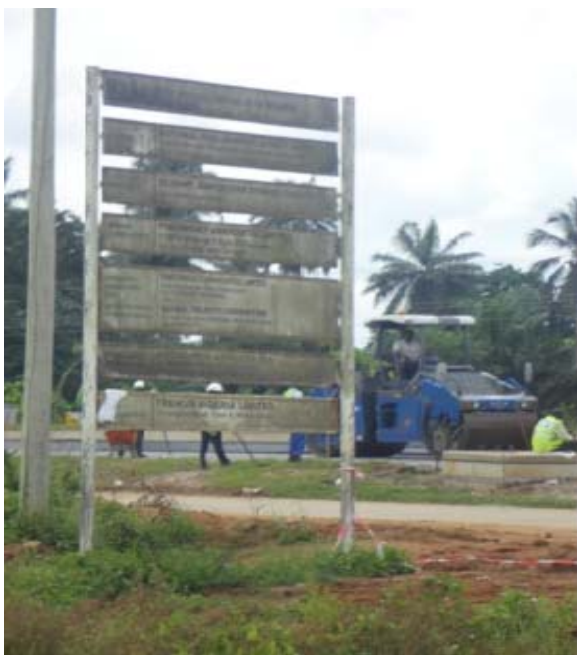
Photo 368: Uyo Silo Complex Under Construction

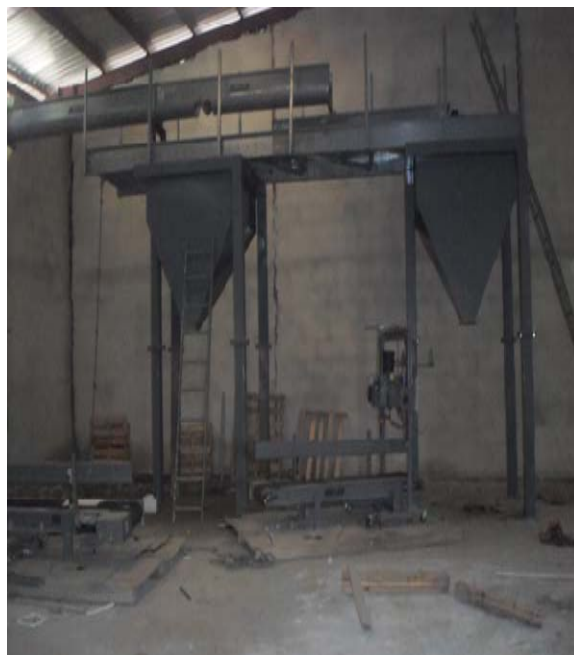
Photo 373: Installation Of Bagging Plant On-Going

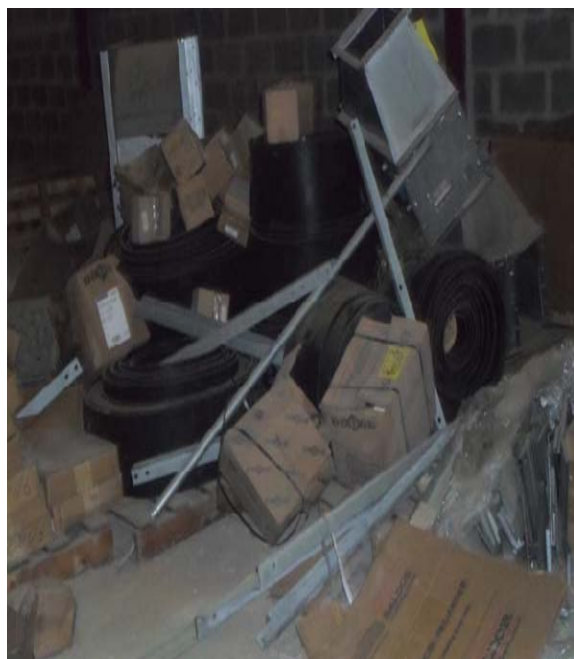
Photo 377: Silo Components In Warehouse
