CONCESSION OF 33 SILO COMPLEXES IN NIGERIA

DUE DILIGENCE REPORT- VOLUME B

TECHNICAL DUE DILIGENCE

March 2015

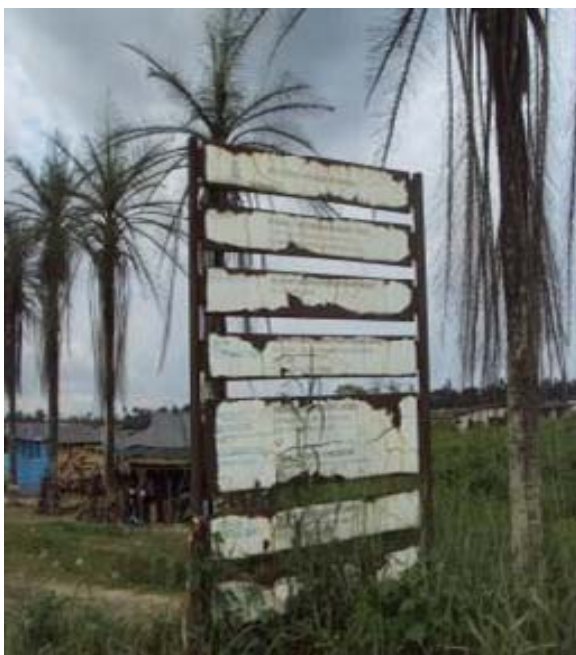
The Silo Complex has a storage capacity of 100,000mt and is currently is 43% complete as indicated by FMARD. It covers an area of 15.54 hectares. The Project site is currently undergoing a redesign for the foundation of all the structures and Silo bins, due to the peculiar nature of the soil in the area.

Equipment has been imported is awaiting installation as depicted by the attached photographs. There is no progress on civil works, as this is dependent on the completion of the final review of the foundation design.

Photo 380: Yenagoa Silo Complex Under Construction

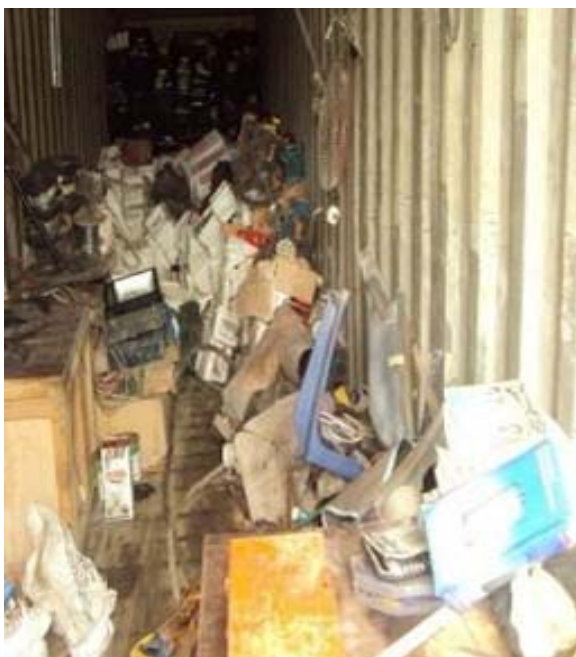
Photo 384: Stored Silo Components

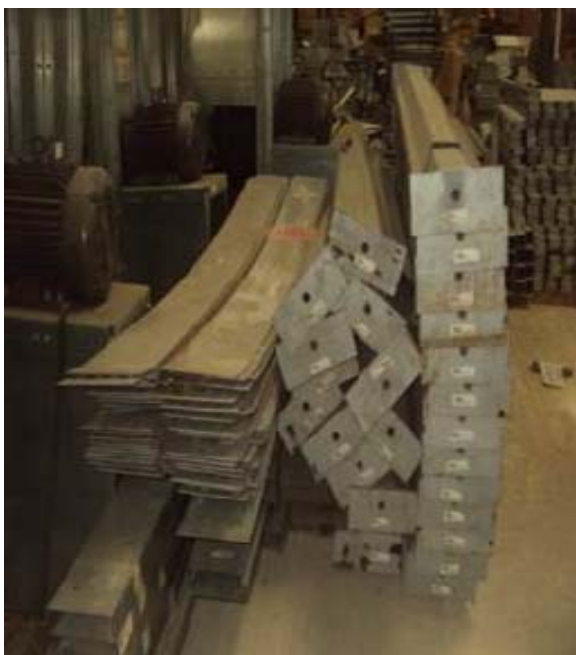
Photo 386: Section Of Uninstalled Silo Components

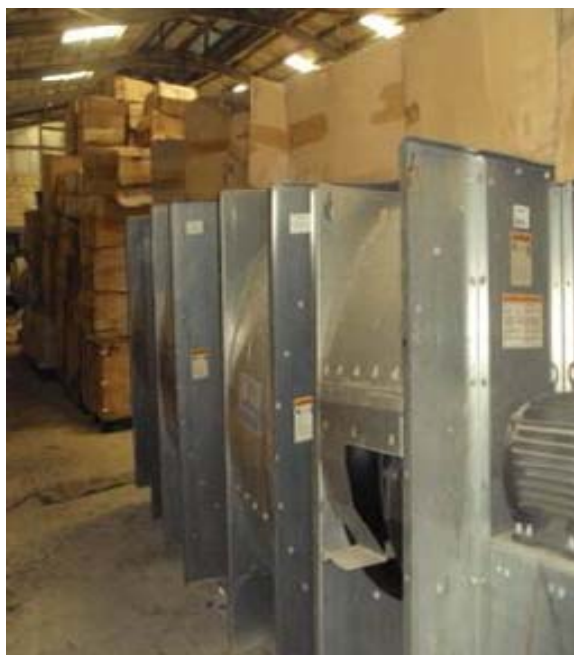
Photo 387: Uninstalled Centrifugal Aerators
